Technical Memorandum

Via Email: ginabushong@gmail.com
To: Gina Bushong, Orland Select Board
From: Gillian Williams, P.E. and Charles Grant, P.E., S.E. (MA)
cc: Narramissic Watershed Coalition
Date: August 18, 2025
Re: Phase I – Site Visit and Due Diligence Assistance
 Alamoosook (ME00144) and Toddy Pond (ME00146) Dams
 Orland, Maine
Project No. 2502852

Toddy Pond Dam

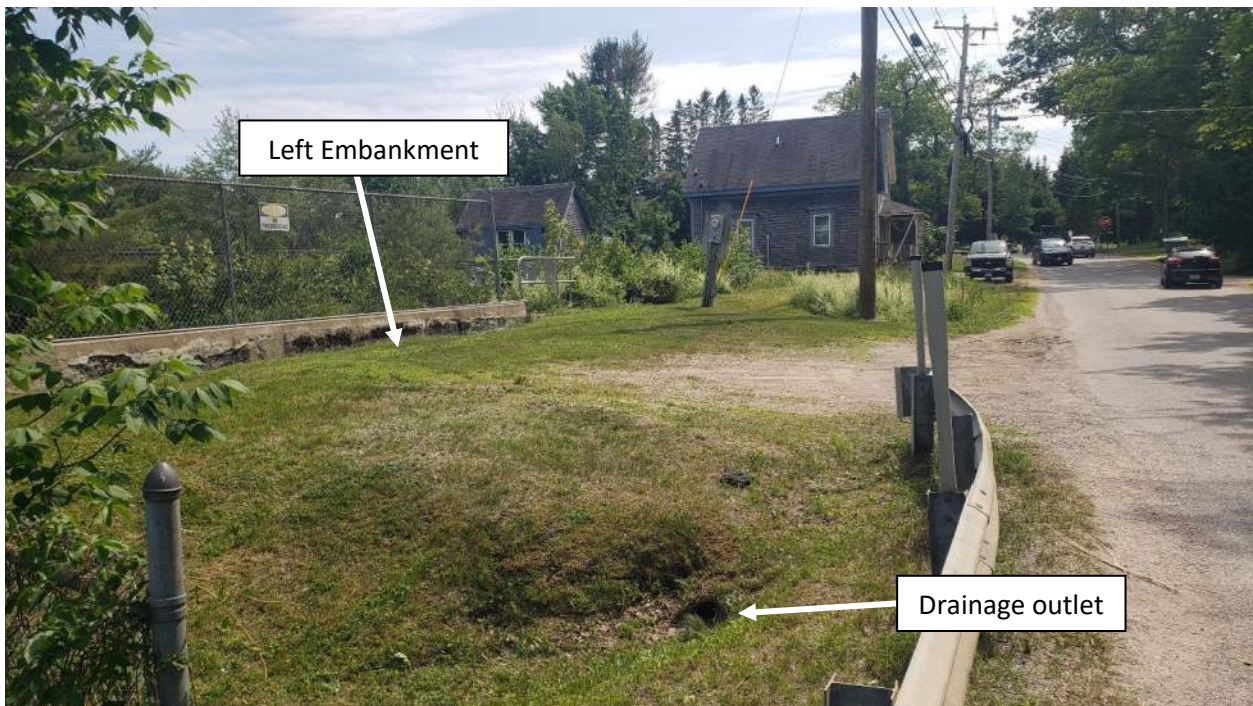
The embankment between the left concrete retaining wall and Hatchery Road was partially mowed (Photo 5). The embankment downstream of Hatchery Road was estimated to be approximately 2V:1H. Heavy vegetation, including mature trees, was observed on the embankment downstream of Hatchery Road (Photo 6). Vegetation was also observed upstream of the left retaining wall (Photo 2). Spalling and efflorescence were observed on the left retaining wall (Photos 3, 4, and 5).

Photo No. 5 – View of left embankment and abutment from Hatchery Road bridge, looking left/upstream.

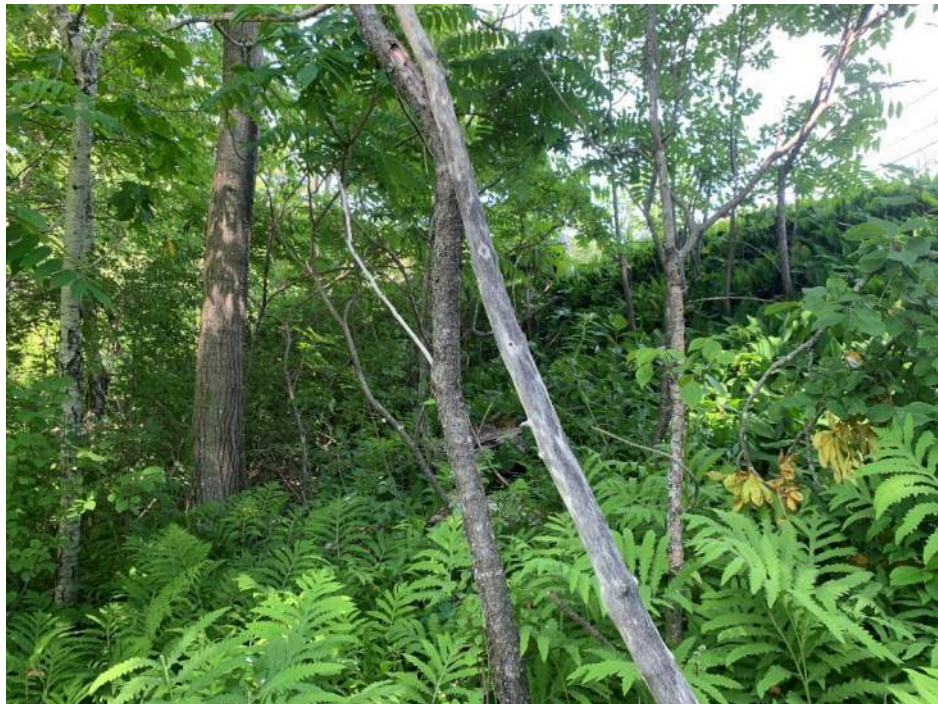
Photo No. 6 – Downstream side of left embankment (downstream of roadway), looking right. Note vegetation and large trees.

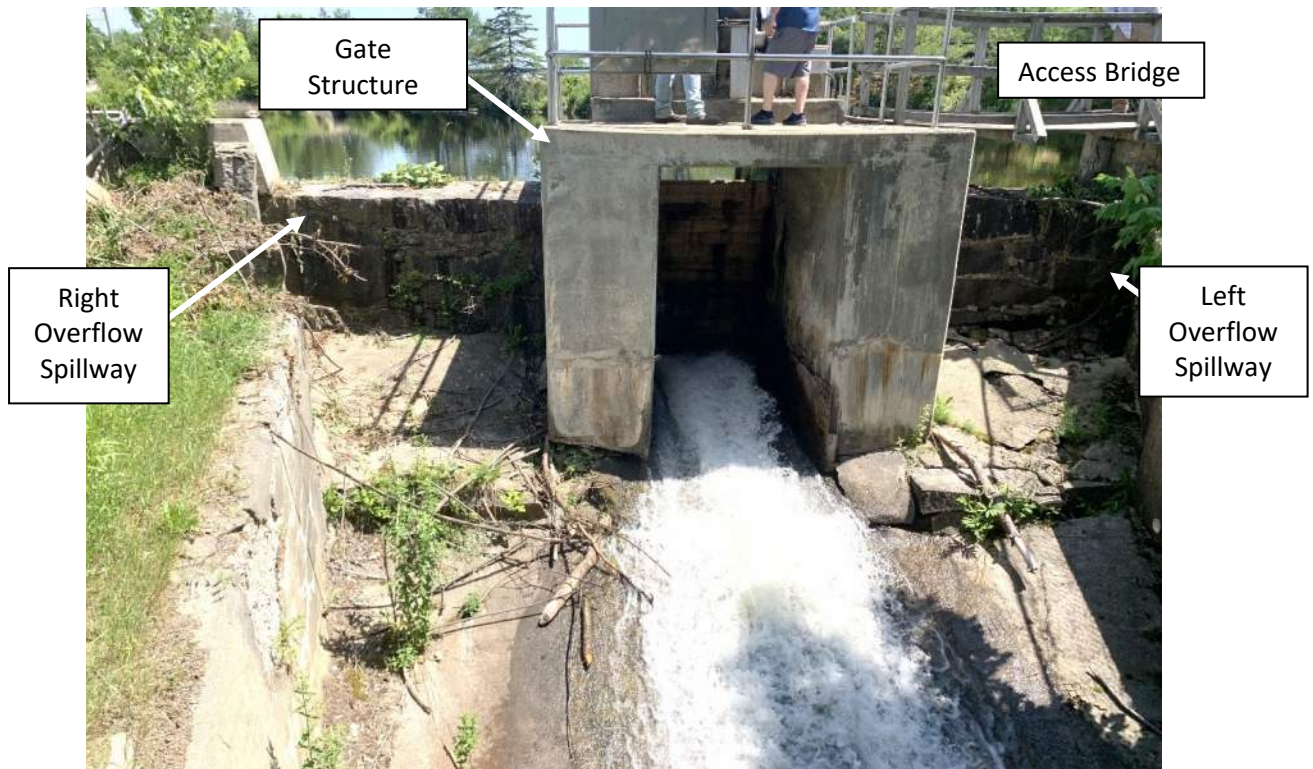
The condition of the granite block overflow spillways was consistent with previous inspection reports. Young vegetation was observed growing on the crest and the downstream face of the right overflow spillway (Photos 3 and 7). Branches were observed on both spillway crests. Voids between granite blocks were observed on the downstream faces of the spillways. Seepage was observed coming from the bottom of the spillway walls. The rate of the seepage was estimated to be approximately 1 to 2 gallons per minute for each of the spillways (Photo 23).

The concrete apron downstream of the spillways and gate structure was in poor condition (Photo 7). Significant cracking and section loss was observed. Exposed steel mesh reinforcing was observed. Branches and vegetation were observed on the apron. The concrete was patched in the past but appeared to be separating from the original concrete. When the gate was opened, water was observed to flow under portions of the concrete. Epoxy grout was reported to have been applied to the upstream faces of the dam by divers in 2012 or 2013. While Figure 1 indicates that the sills of the left and right overflow spillways are both at El. 165, observations during the field visit indicate that the sill at the right spillway is approximately 2 inches higher than the left spillway (Photos 3 and 4).

Photo No. 7 – View of dam from Hatchery Road bridge, looking upstream while the gate was opened. Note the debris and vegetation on the spillway aprons.

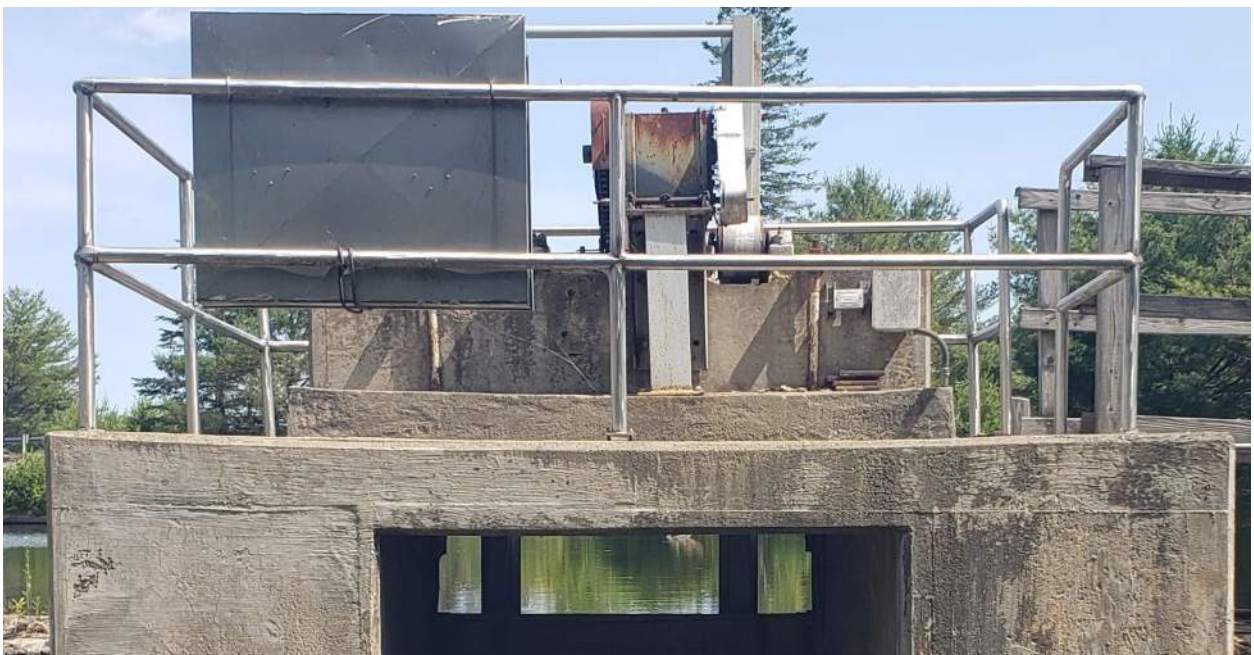
The deck of the gate structure appears to be deflected. This is evidenced by the connection of the stainless-steel railing to the concrete slab (Photo 8). The bottoms of the two outer downstream-most railing posts are flush with the concrete slab of the gatehouse, but the bottom of the center downstream-most railing is approximately $\frac{1}{4}$ to $\frac{1}{2}$ inch above the concrete slab. This suggests that the center of the concrete slab sags below the edges of the slab. The gate was reported to have been replaced in 2015. Beavers are reported to periodically block the gate and fishway intakes with mud. The gate intake is cleared by opening the gate. The gate is operated with a handheld battery-operated drill. Rust was observed on the gate mechanism on the operator platform (Photo 25). The gate was opened several inches during the inspection using a battery powered hand drill. No issues with gate operation were noted during the inspection. The gate components and gears were reported to have been recently greased.

Photo No. 8 – View of the gate structure/operator platform from Hatchery Road bridge, looking upstream. Note the deflection of the concrete slab.

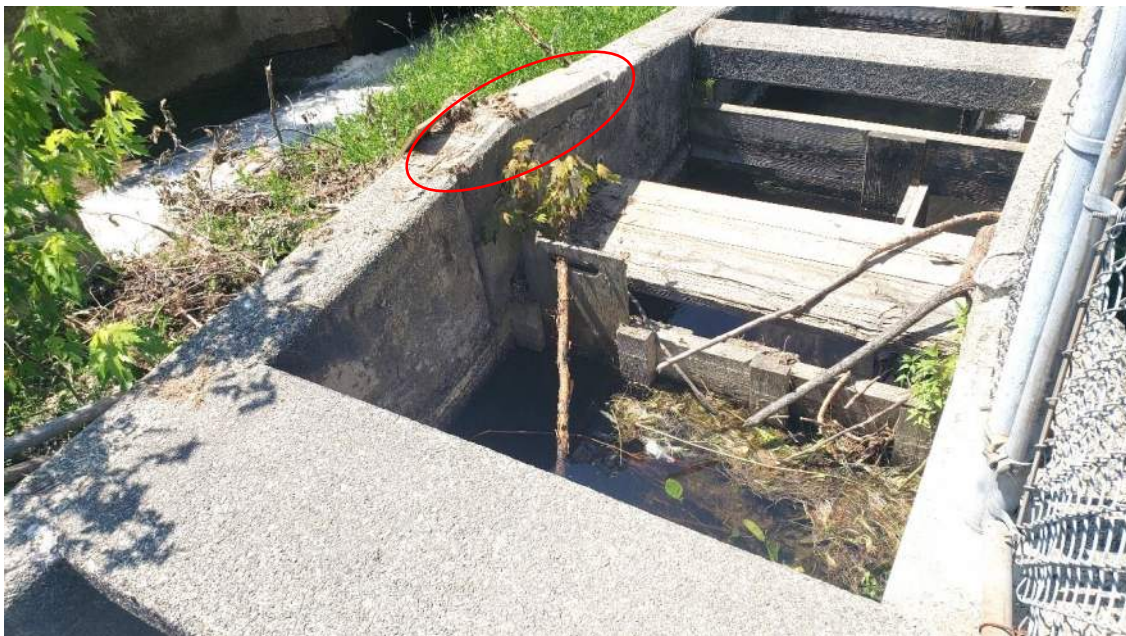
Photo No. 16 – View of top of fishway, looking downstream. Note debris and evidence of concrete repair.

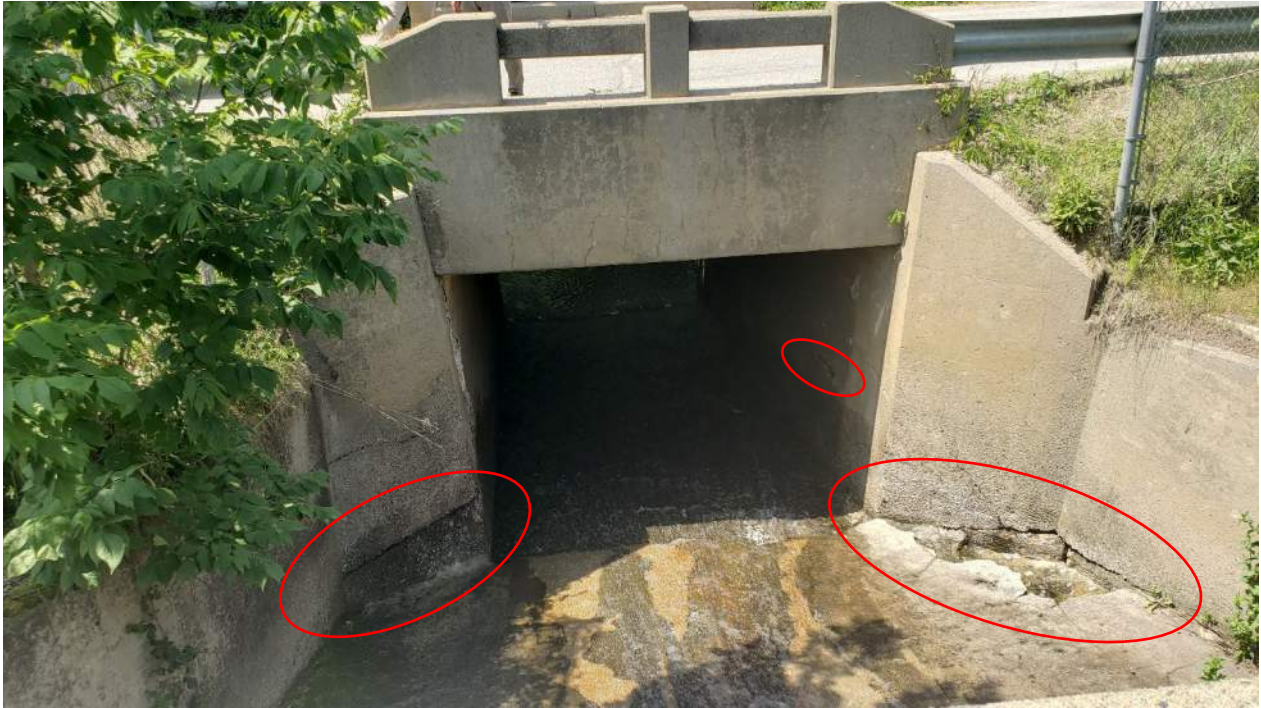
The Hatchery Road bridge downstream wingwalls exhibited concrete loss approximately 6 to 12 inches above the tailwater elevation (Photos 13 and 14). Cracking and efflorescence were observed on both downstream wingwalls. The bridge deck appeared to be in good condition. Cracking, efflorescence, and some spalling was visible on the walls under the bridge deck (Photo 20).

Photo No. 20 – View from top of gate looking downstream toward Hatchery Road bridge. Note cracking and concrete loss.

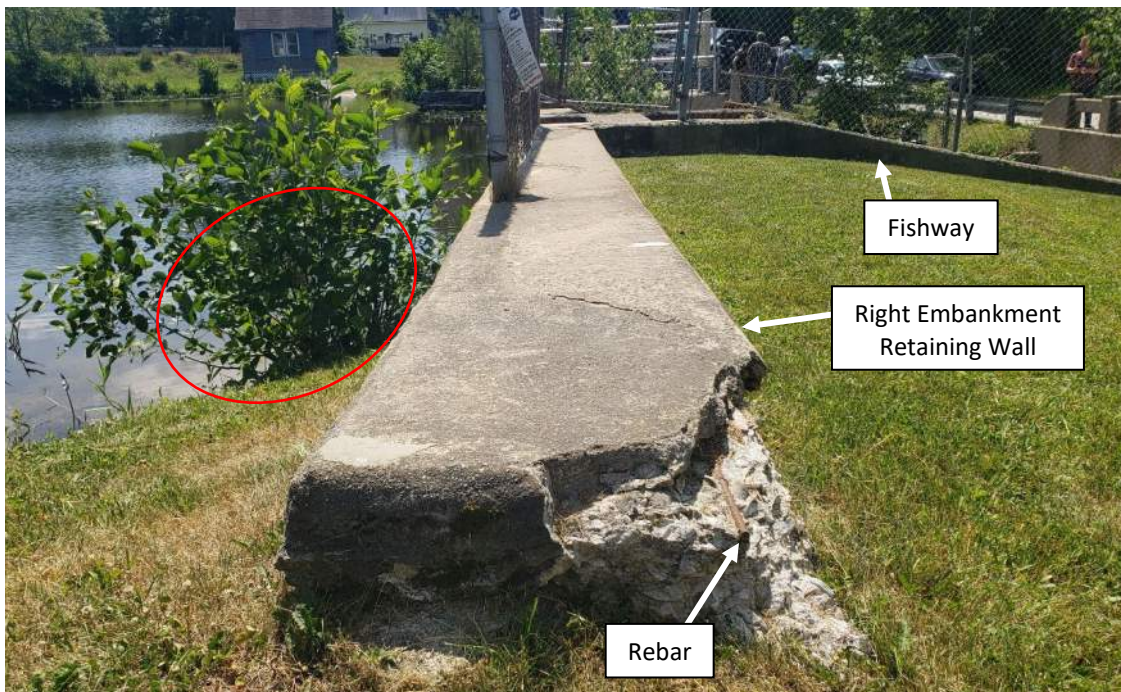
The embankment between the right upstream concrete retaining wall and Hatchery Road was mowed (Photo 21). The embankment downstream of Hatchery Road was estimated to be approximately 2V:1H. Heavy vegetation was observed on the embankment downstream of Hatchery Road (Photo 13).

Cracking and concrete loss were observed at the right end of the retaining wall (Photo 21). Vegetation was observed upstream of the retaining wall (Photo 2).

Photo No. 21 – View from right abutment, looking left. Note upstream vegetation and concrete loss.

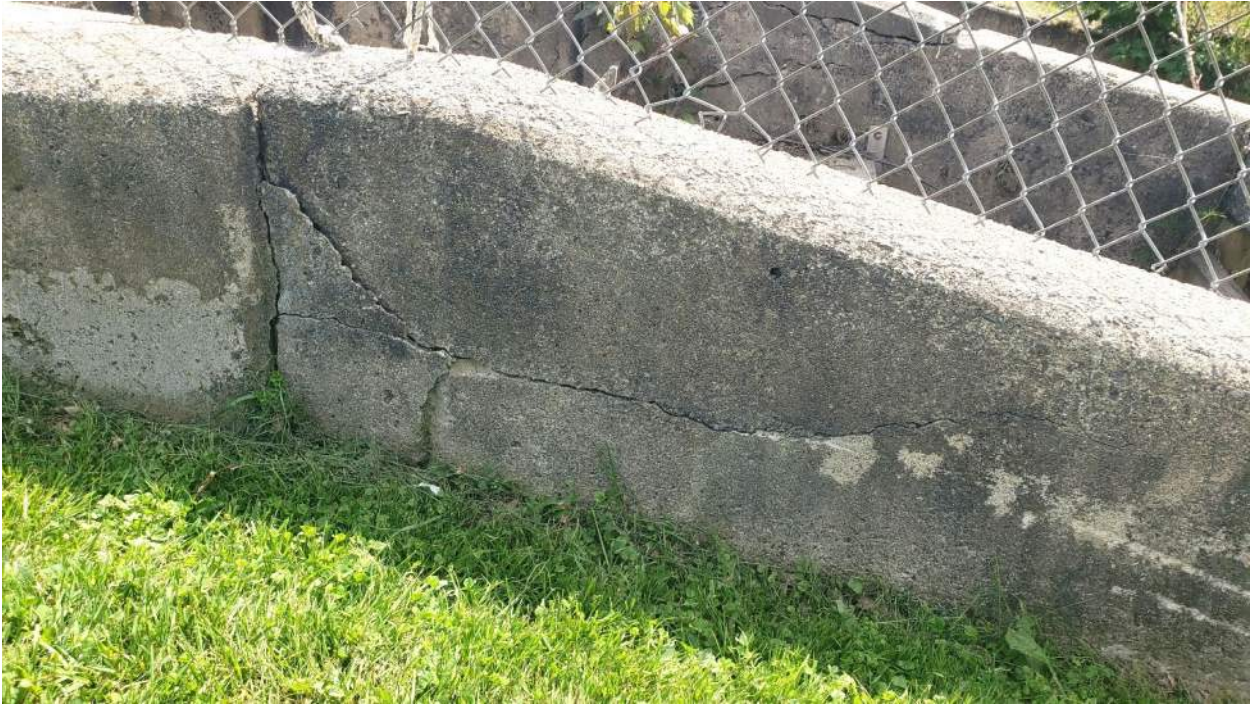
Photo No. 22 – View of right wall of fishway from right embankment, looking left. Note cracking.

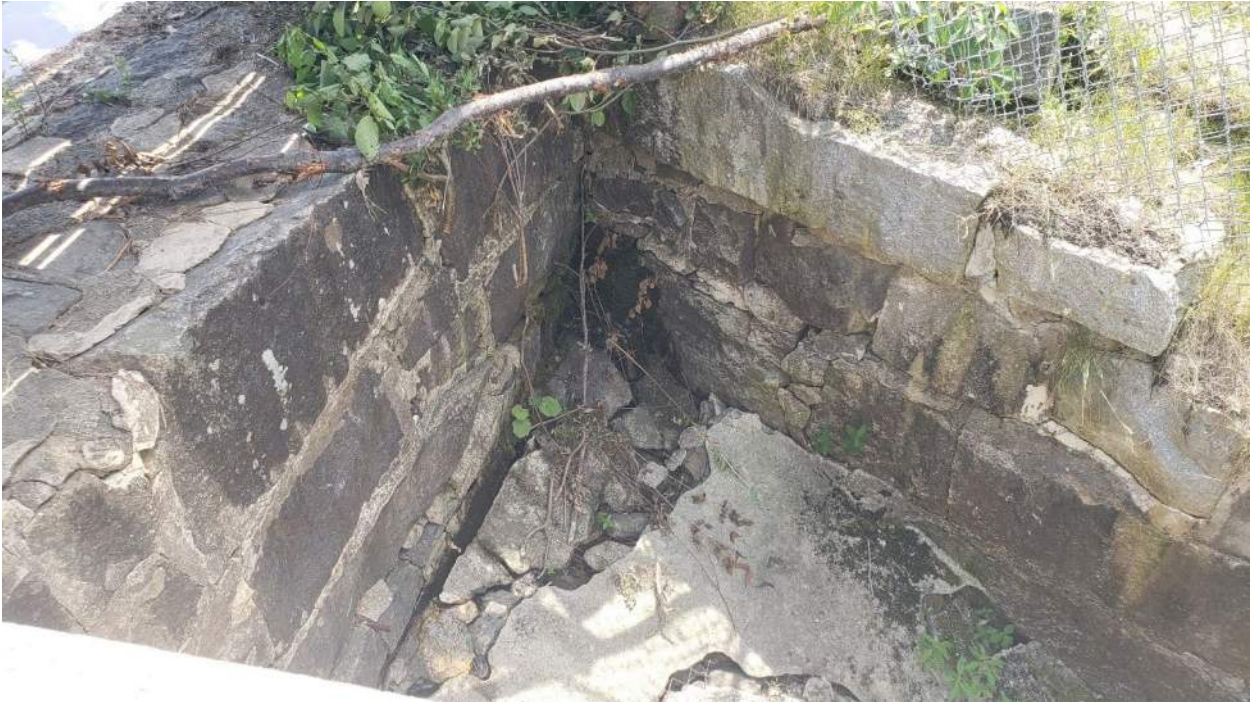
The left retaining wall is granite masonry immediately downstream of the spillway (Photo 24). It transitions to concrete after approximately 5 feet. The concrete appeared to be in fair condition. Small trees were observed growing on top of the concrete wall.

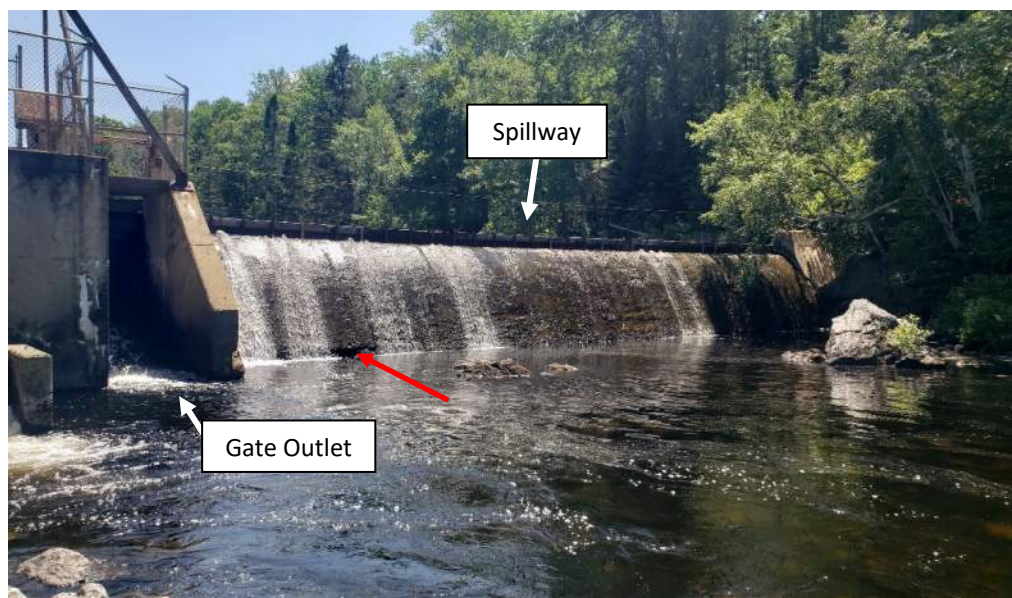
Photo No. 9 – View of gate outlet and spillway from right downstream shore, looking upstream. Note deterioration at concrete lift joint (red arrow).

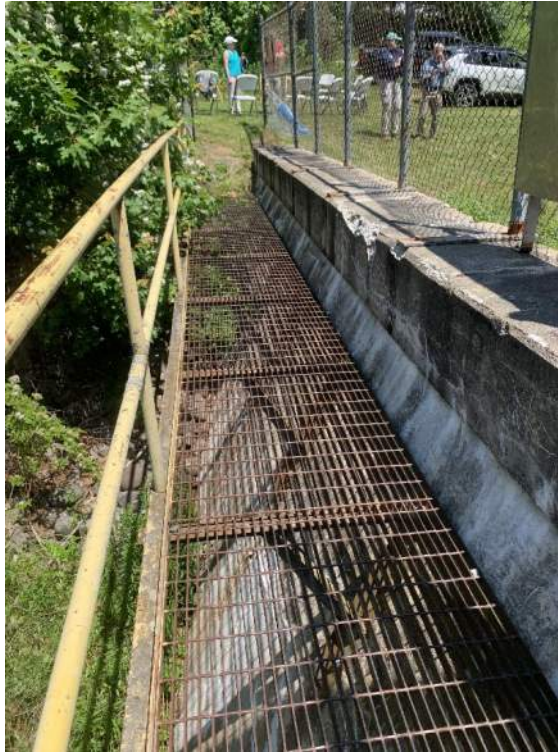
Photo No. 13 – View of access walkway, railing, and right abutment from the top of the intake structure, looking right. Note efflorescence and spalling.

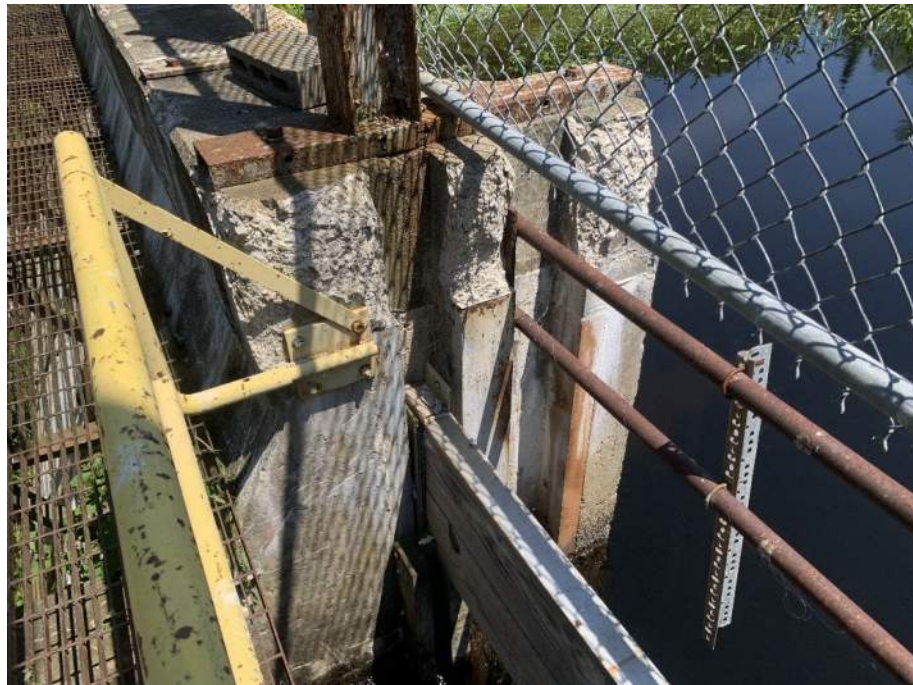
Photo No. 18 – View of right side of fishway intake. Note concrete loss.

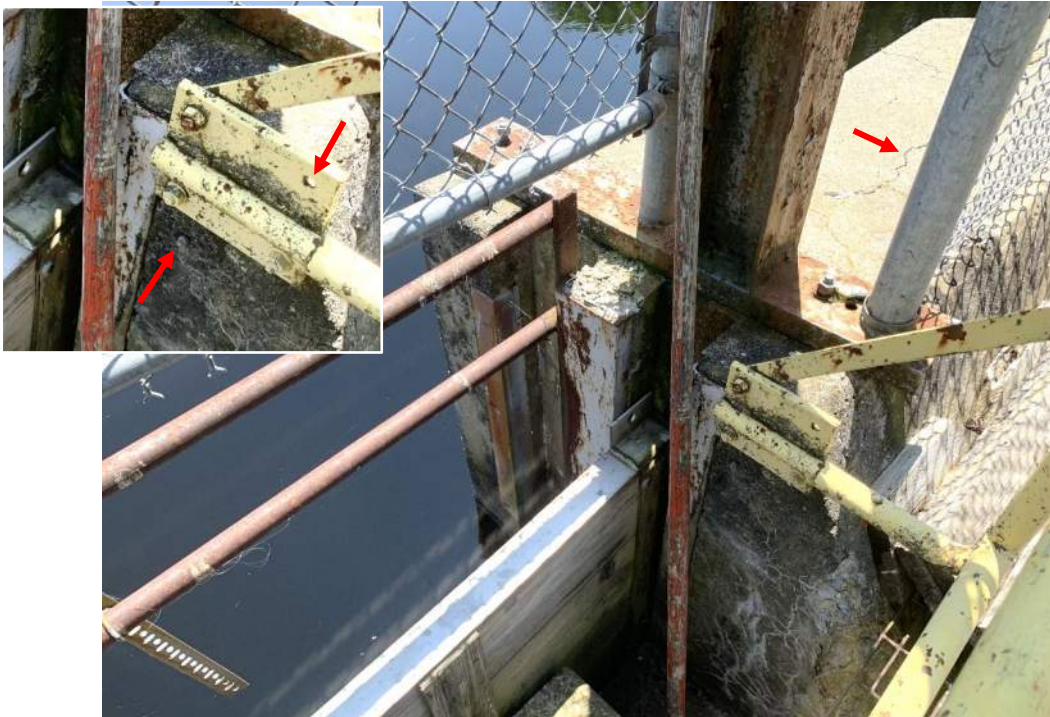
Photo No. 19 – View of left side of fishway intake. Note connection with walkway railing. Two screws appear to have a minimal distance to the edge of the concrete. Note cracking to the left of the fishway intake.
