Falls Bridge Advisory Committee Meeting #5 – Existing Conditions

BAC Meeting #5 – Existing Conditions

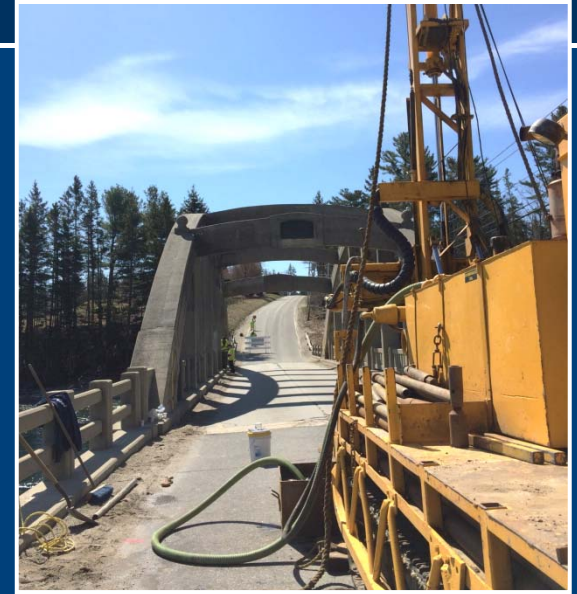
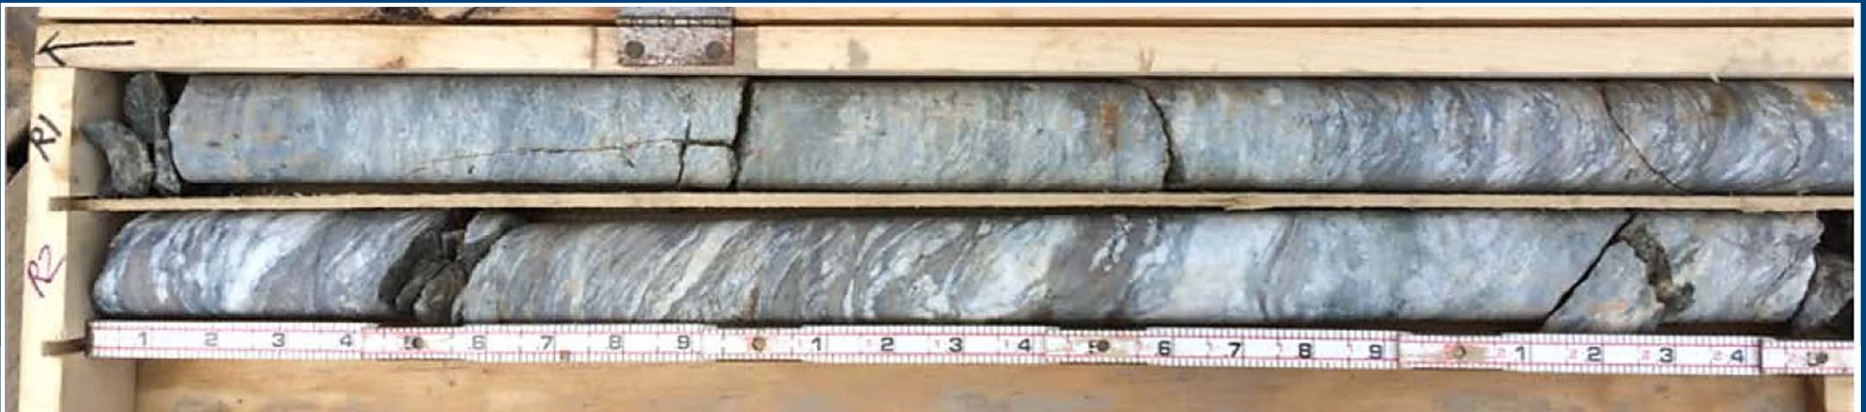
Photo 5: Core box containing dried core from test boring BB-BHF-202:
Left side of core box (top 2.5-foot portion of cores).

Slots from top to bottom:

- 1) BB-BHF-202, R1 (9 to 14 ft);
- 2) BB-BHF-202, R2 (14 to 19 ft).

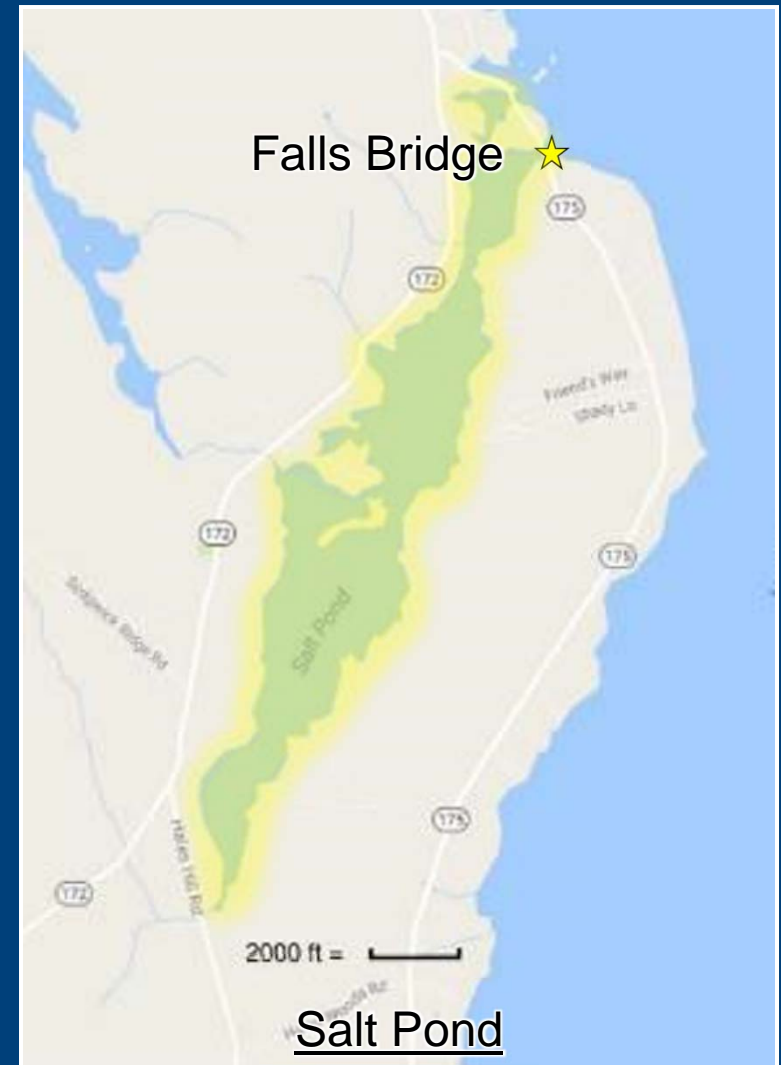
Salt Pond Tidal Basin

- Large tidal basin ~1.1 sq. mile
- Tidal variations of ~10.5' to 11.5' in Blue Hill Bay
- Tidal variations in Salt Pond somewhat less
- Falls bridge is only major inlet

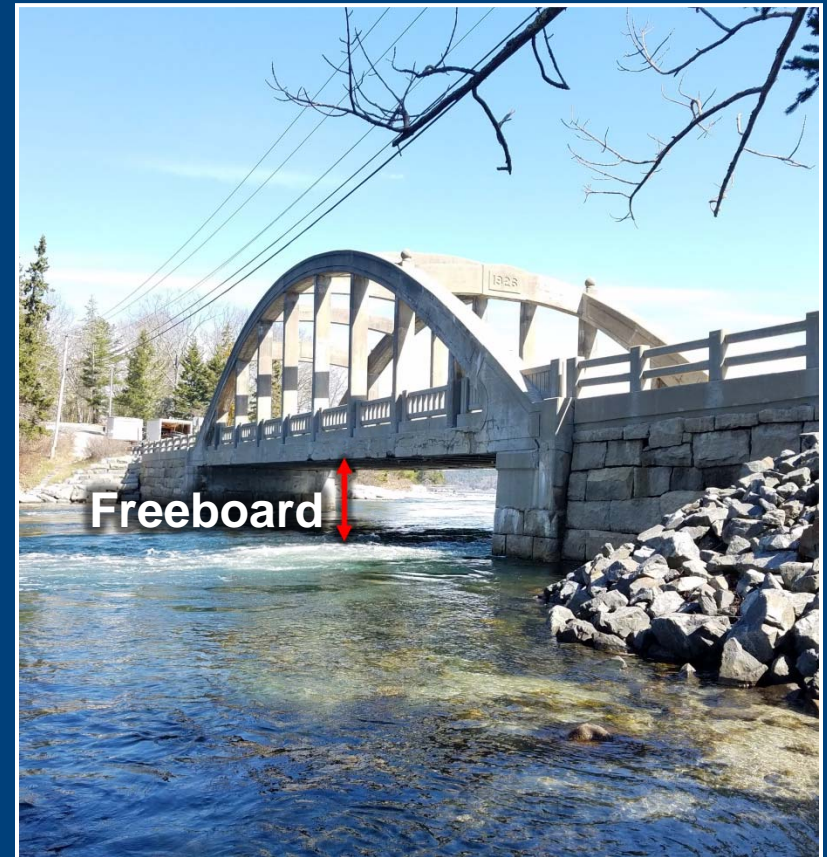
Existing Bridge Opening

- Min. Freeboard: 6 Feet
- Width: 100 Feet
- Min. Depth: 6 Feet at low tide
- Very small opening relative to size of basin tidal basin

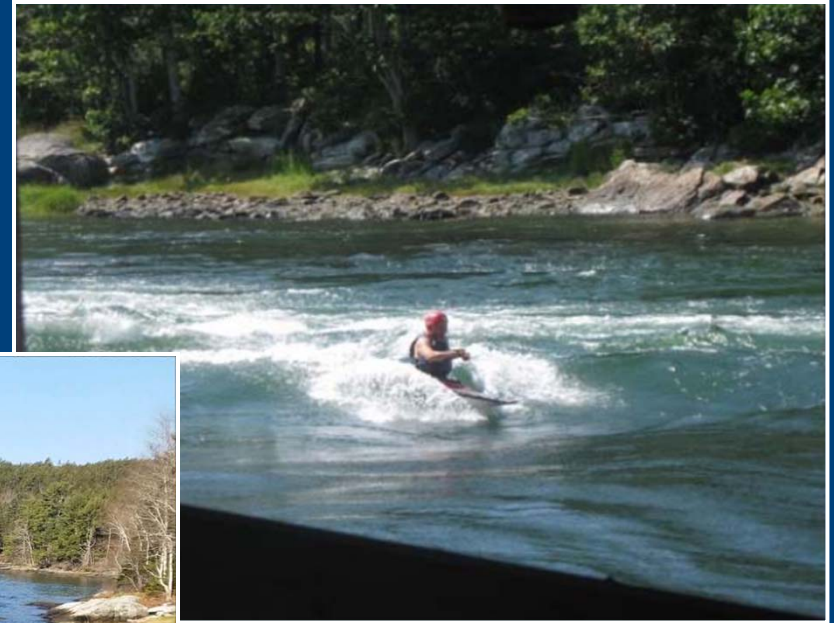
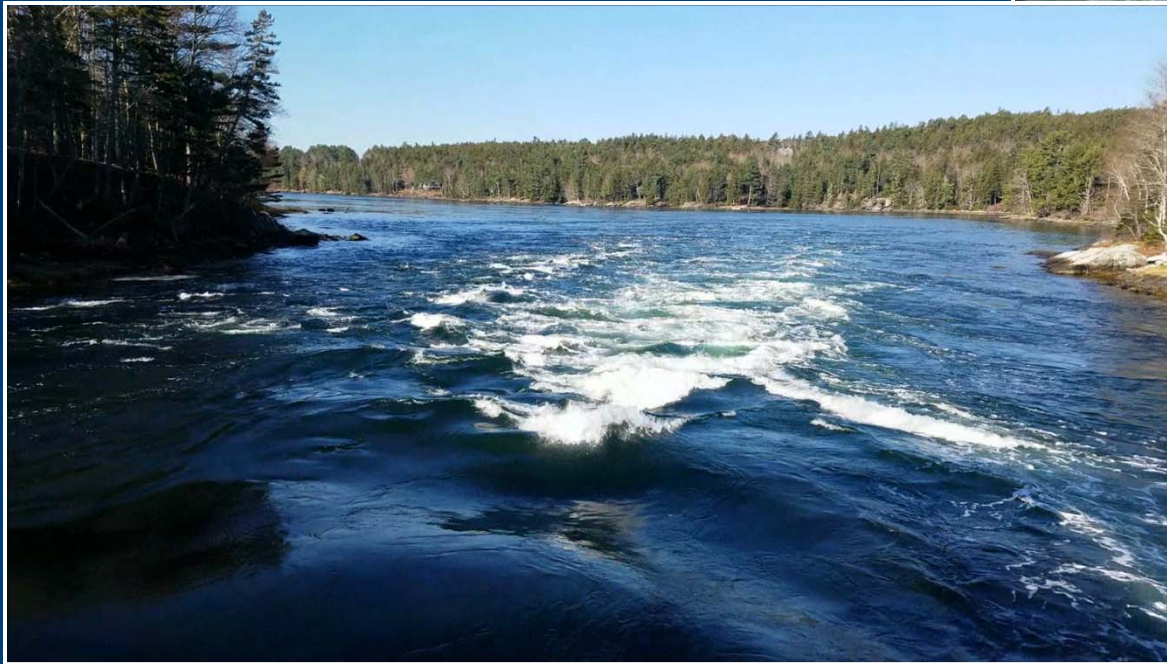
Hydraulics

- Max. currents of ~15 Ft./Sec.
- Turbulent flow & standing rapids

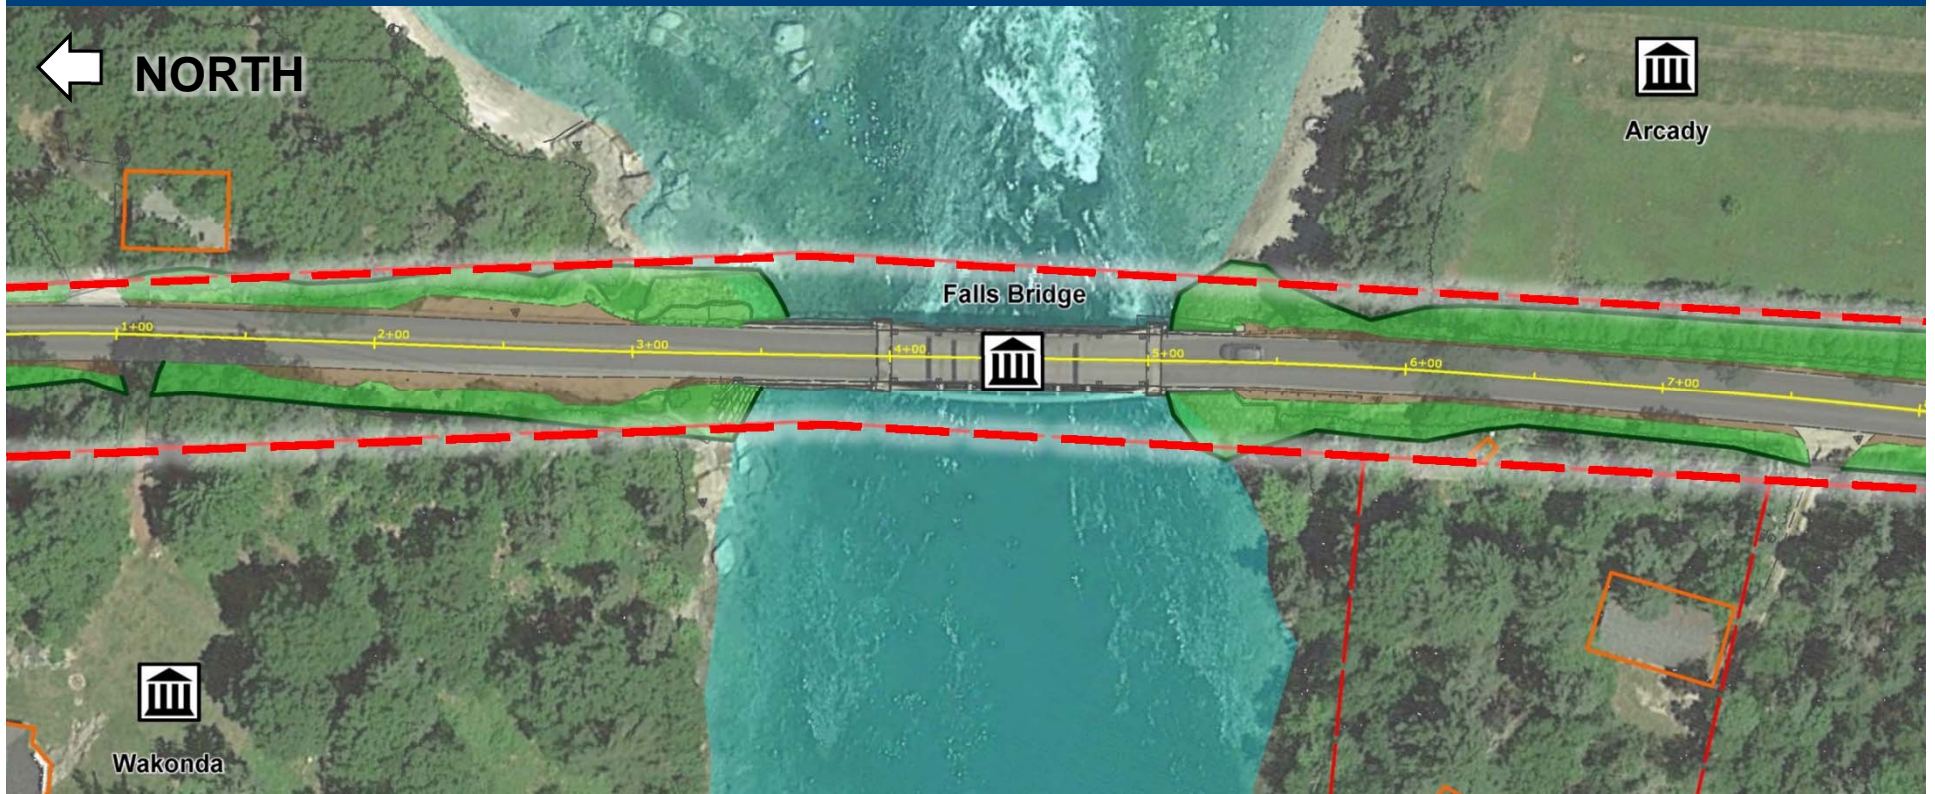
Public Right-of-Way

- 66 Feet wide
- Roadway not centered in right-of-way

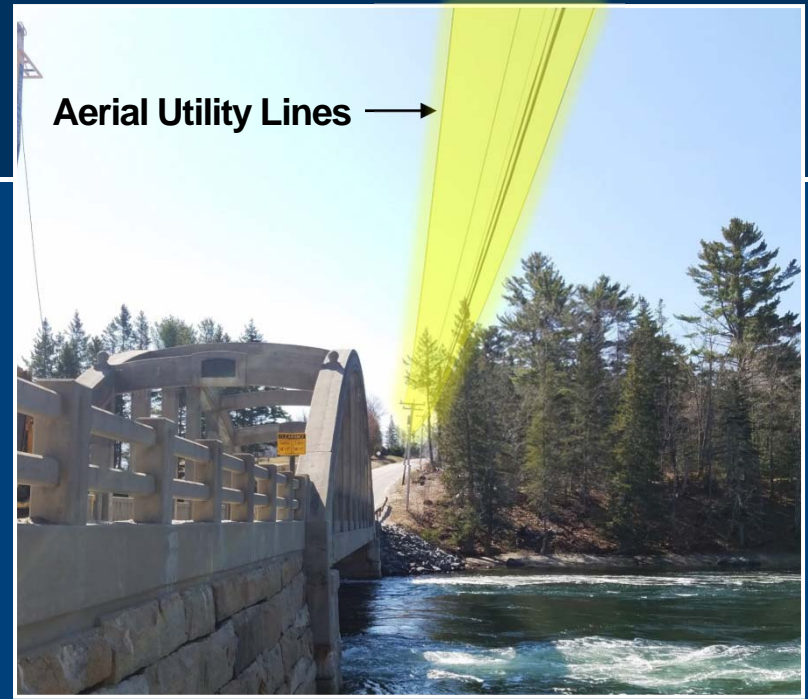
Utility Lines West of Bridge

Aerial Utilities Present:

- Bangor Hydro Electric Company
- FairPoint Communications
- Time Warner Cable

Close proximity to bridge

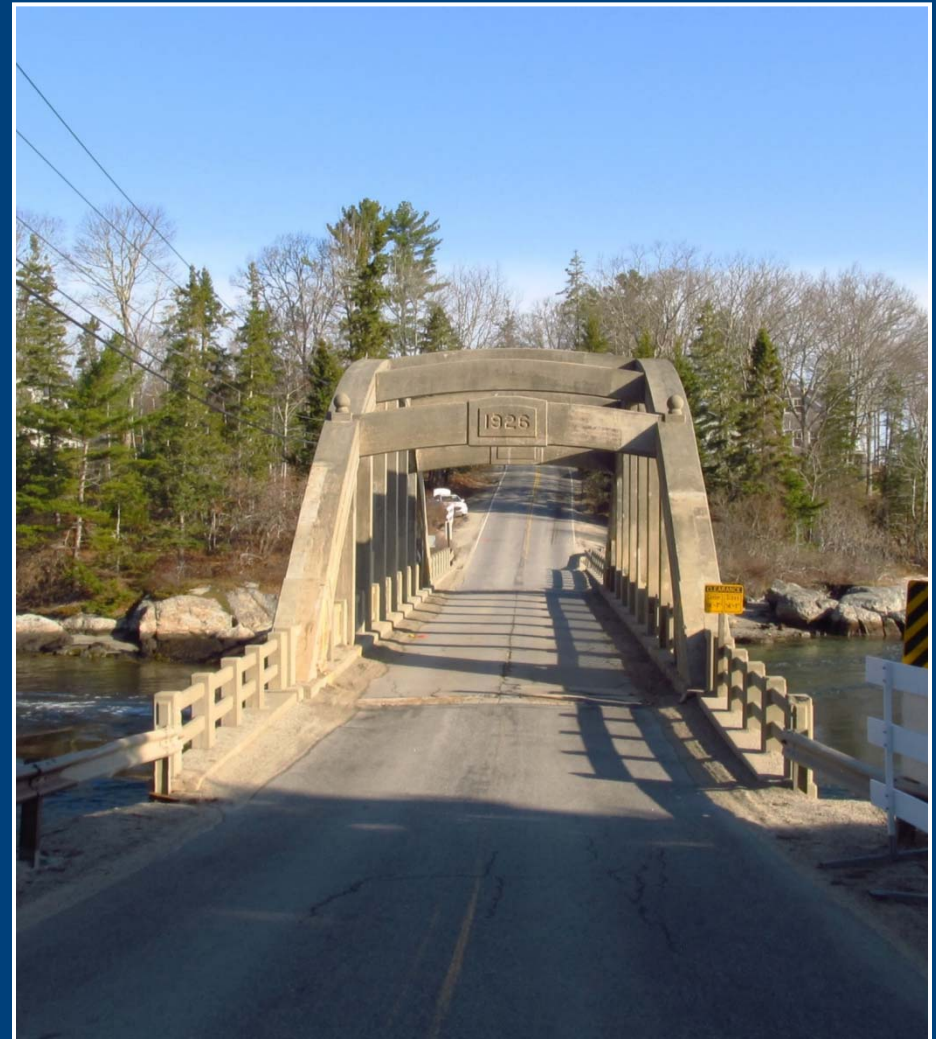
Bridge Geometrics

- Main Span: ± 100 Ft.
- N. Approach: ± 100 Ft.
- S. Approach: ± 30 Ft.
- Max. Vehicle Height: 14'-1"
- Curb-to-Curb Width: 20'-4"

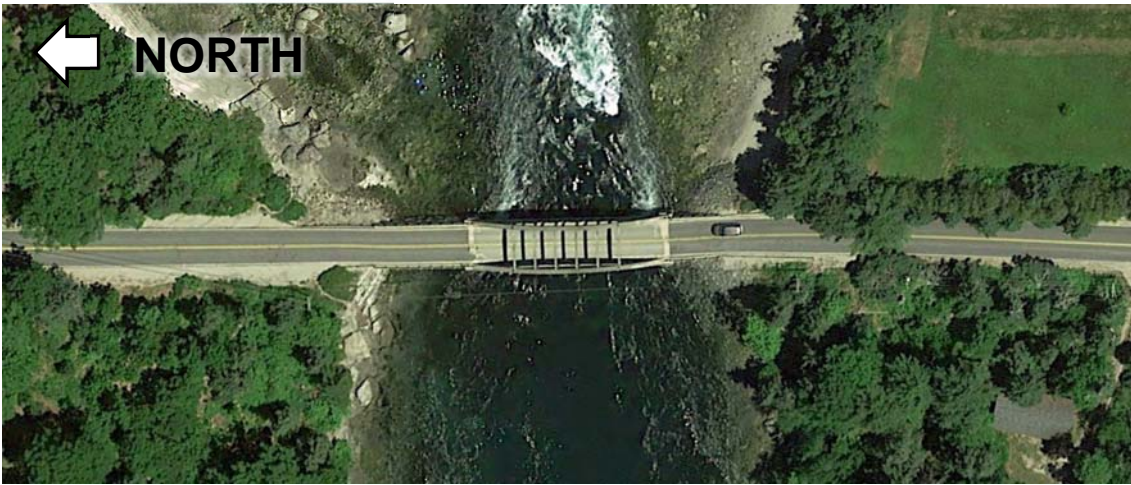
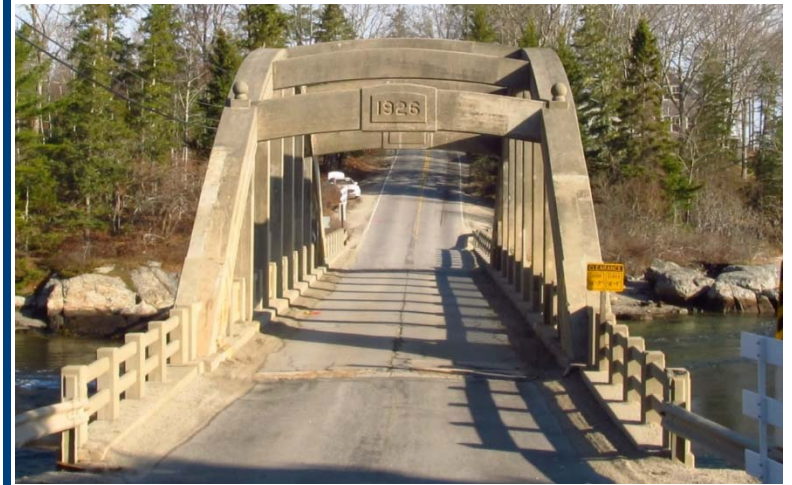
Horizontal Alignment

- Roadway and bridge width is substandard
 - Roadway paved width = ~20', informal shoulders
 - Bridge paved width = ~20'-4", no shoulders
 - MaineDOT standards recommended 24' width (lanes + shoulders)
- Minimum curvature, satisfies current design standards

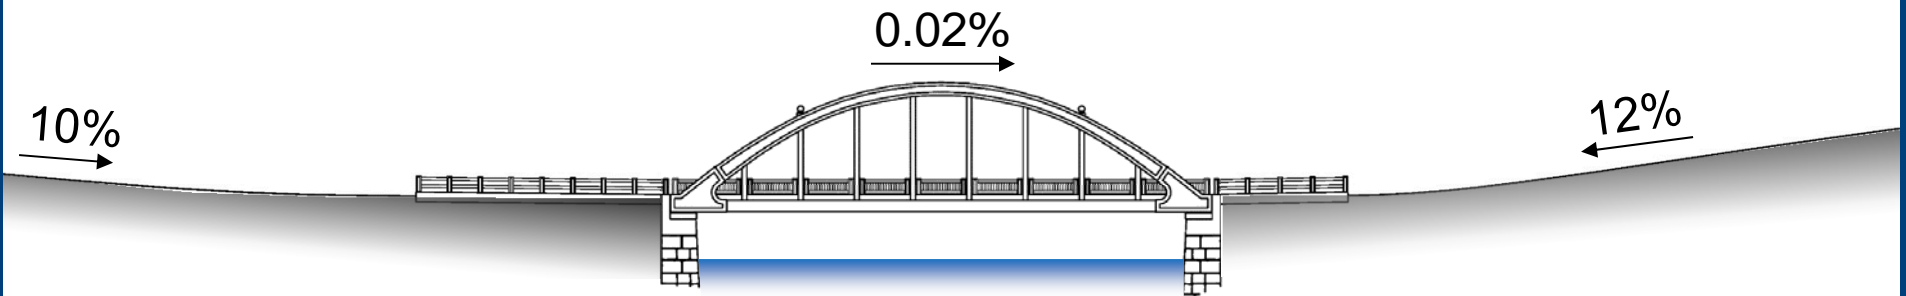
Vertical Roadway Profile

- Bridge is located in the valley of two hills
- Controlling headlight sight distance = 54 feet < 115 feet
 - Sufficient for a design speed of ± 10 mph
- Max. existing roadway grade = 12% > 9% standard

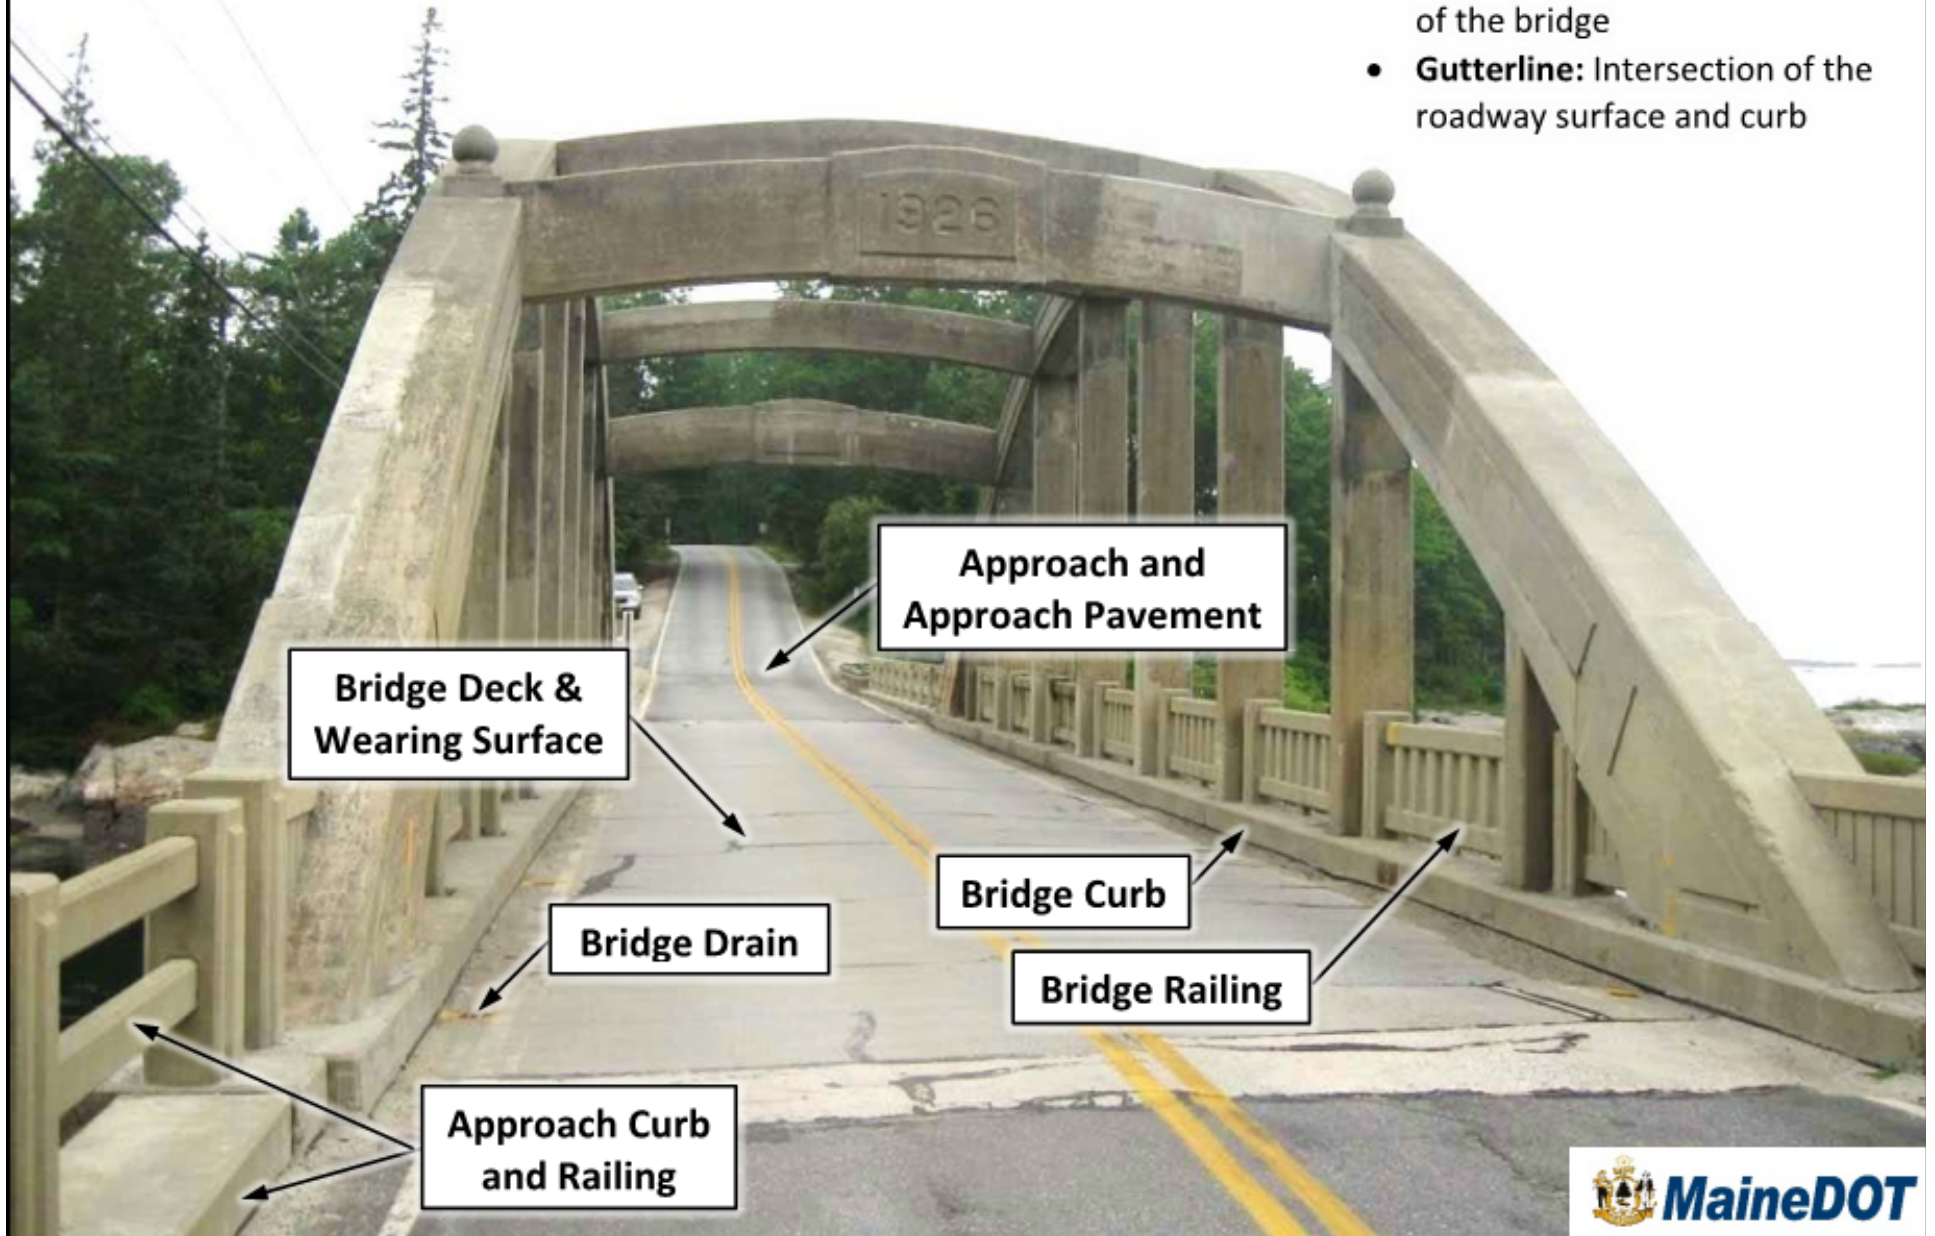
Tied Arch Bridge Terminology

- **Fascia:** Exterior / Outside face of the bridge
- **Gutterline:** Intersection of the roadway surface and curb

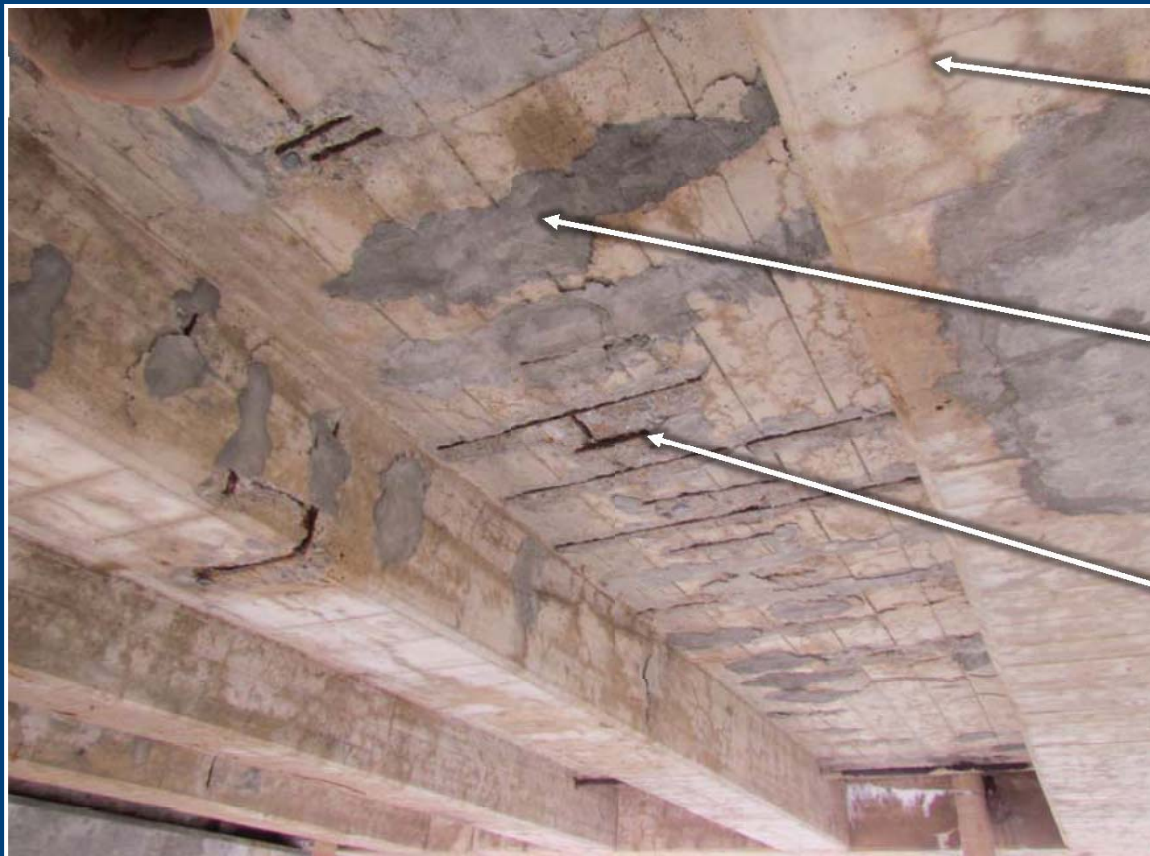
Deterioration on Underside of Deck

Rating = 4 – Poor Condition

Concrete cracking

Area of previous repair

Exposed reinforcing

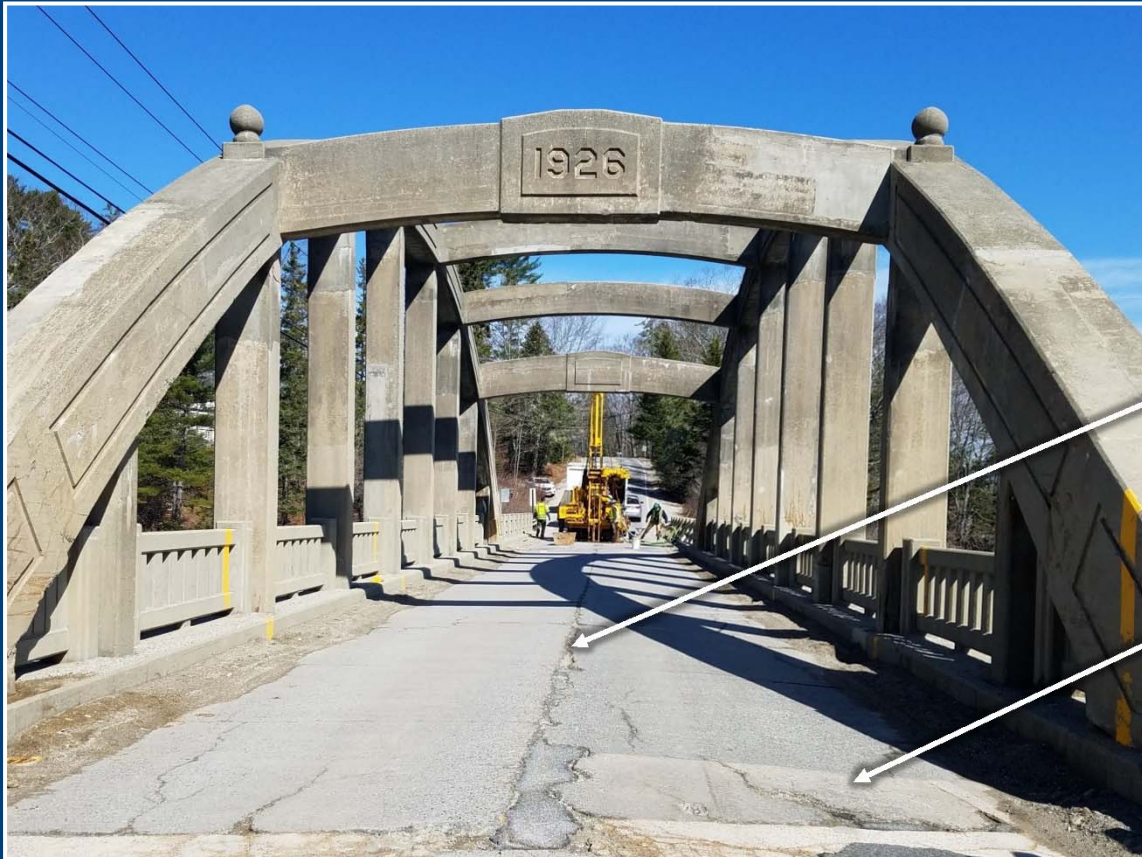
Deterioration at Deck Roadway Level

Rating = 4 – Poor Condition

Areas of heavy cracking throughout

Areas of previous repair throughout

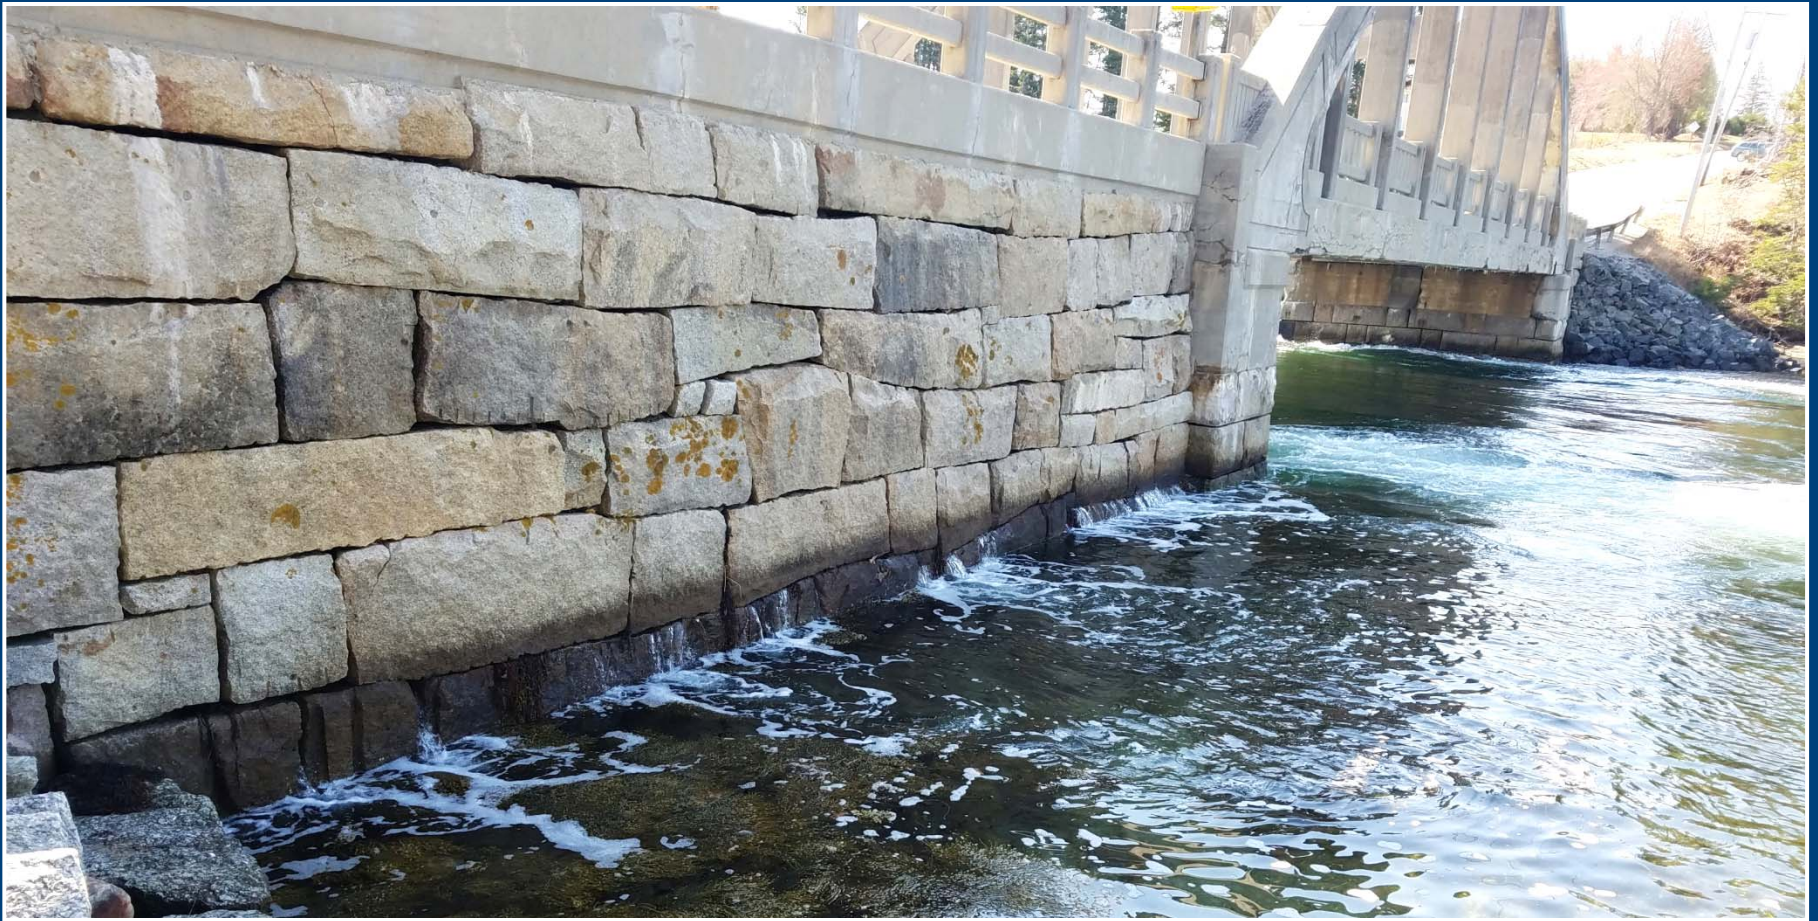
Bridge Condition - Substructure

Rating = 4 – Poor Condition

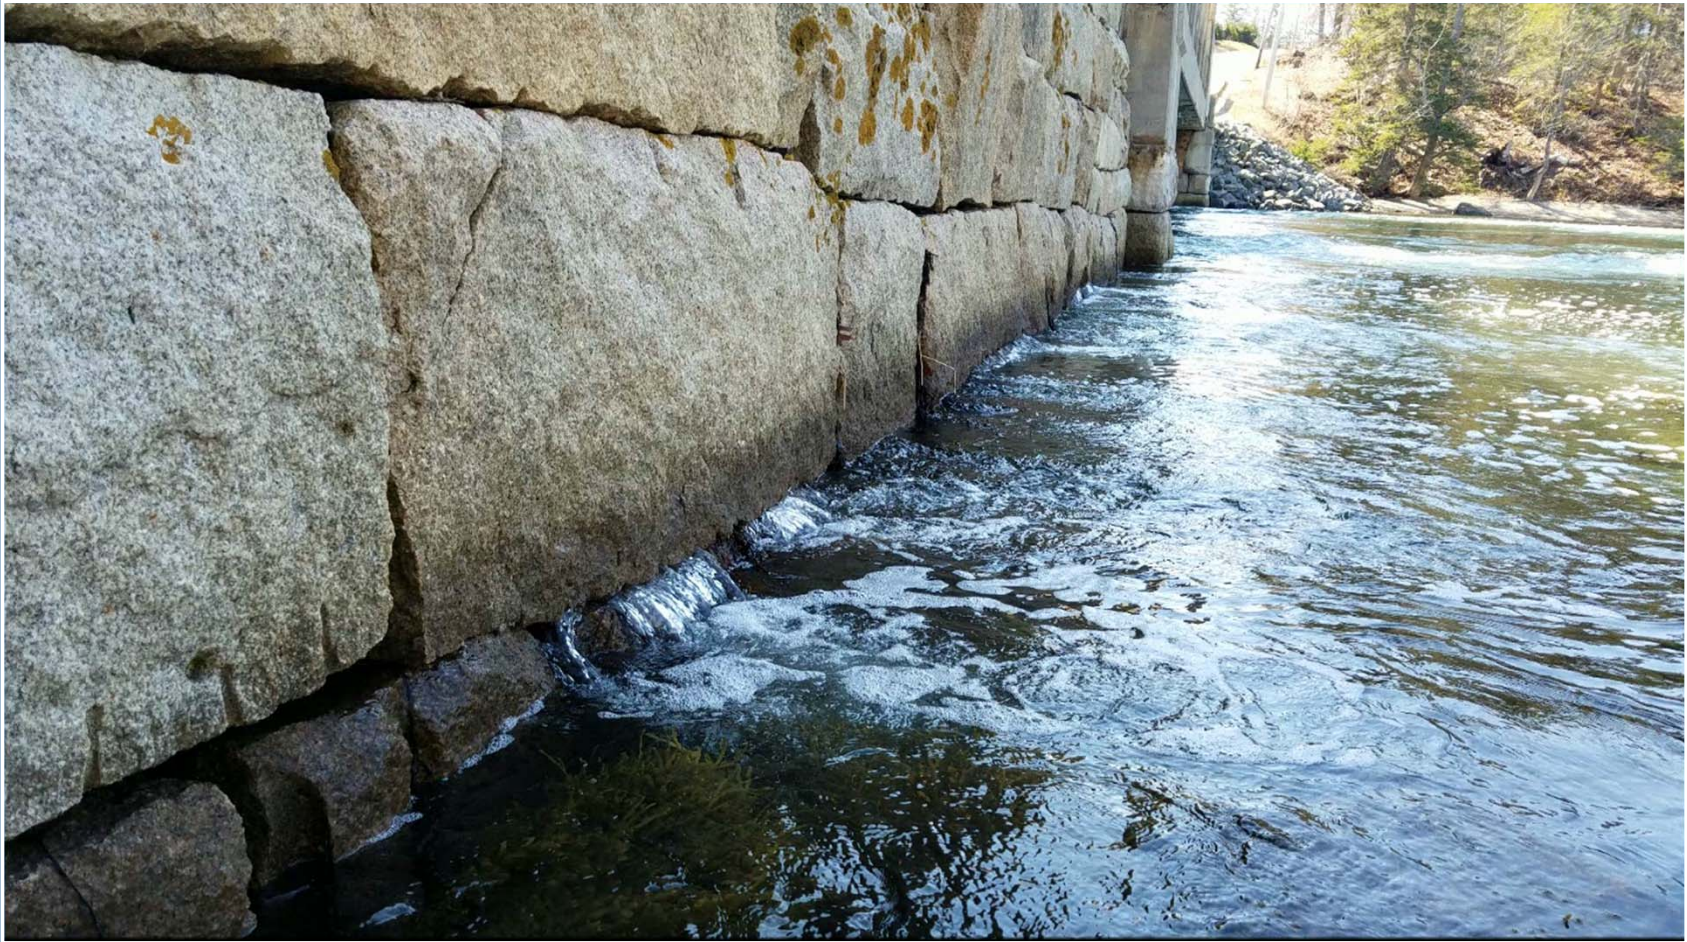
Bridge Condition - Substructure

Rating = 4 – Poor Condition

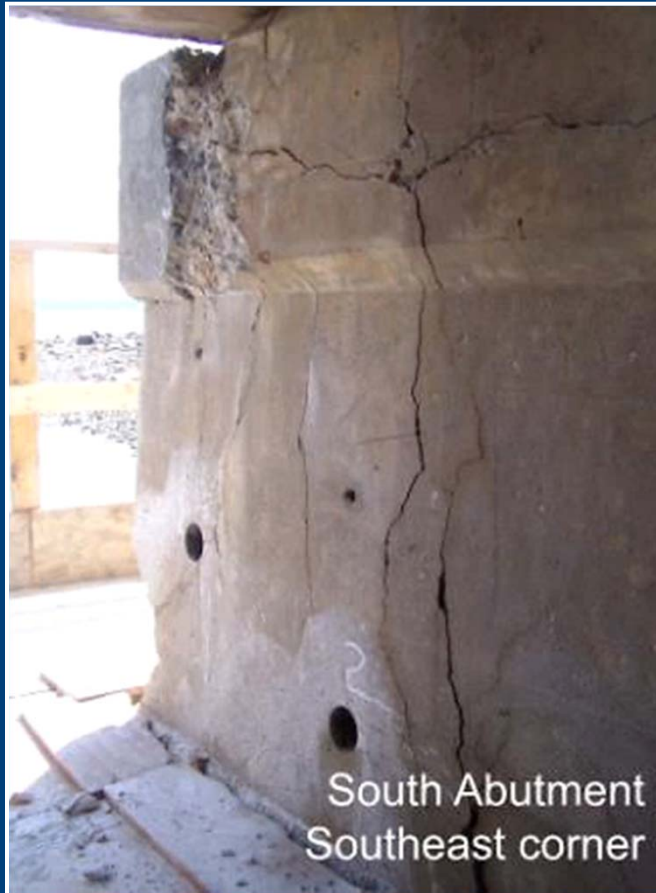
Concrete Spalling at Abutment

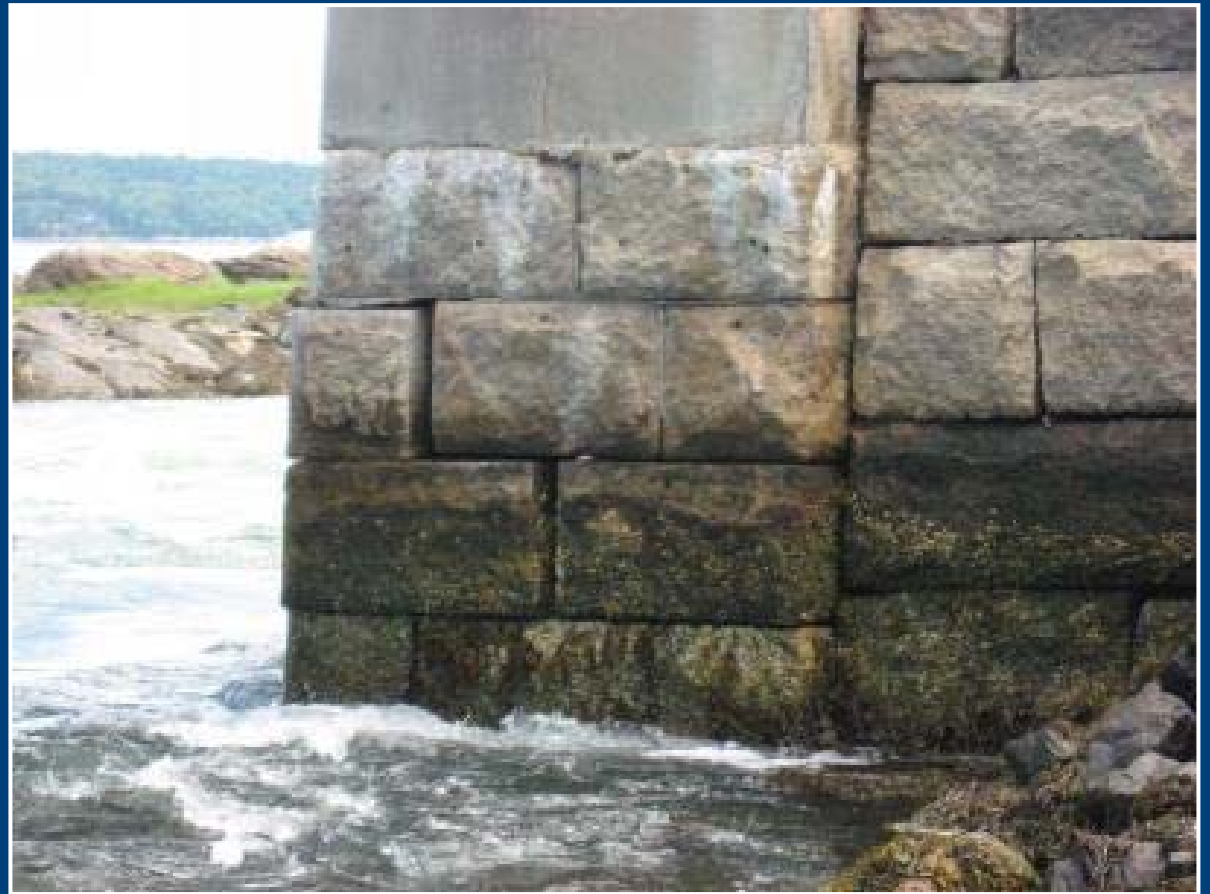
Settling Masonry

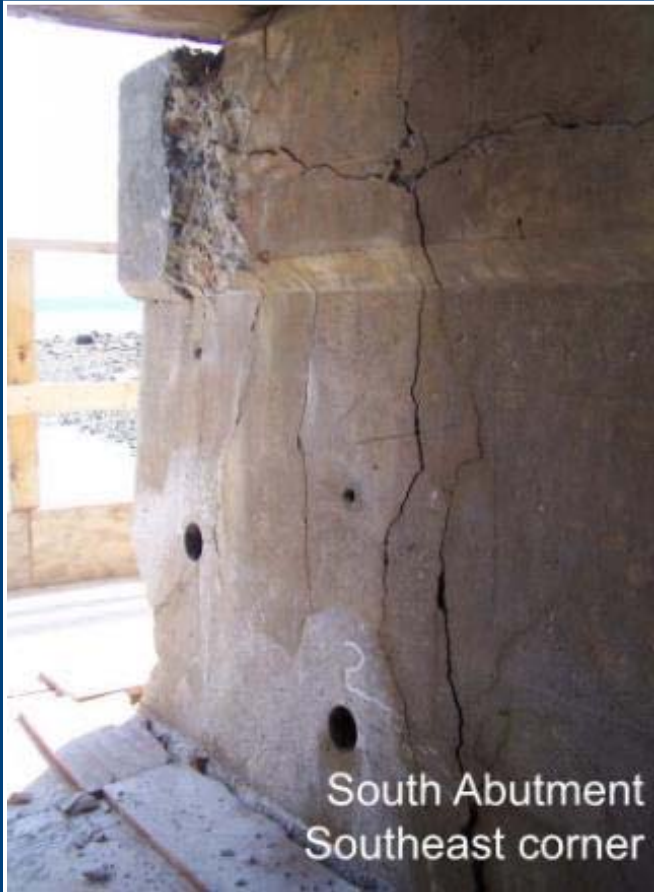
South Abutment
Southeast corner

Concrete Spalling at Abutment

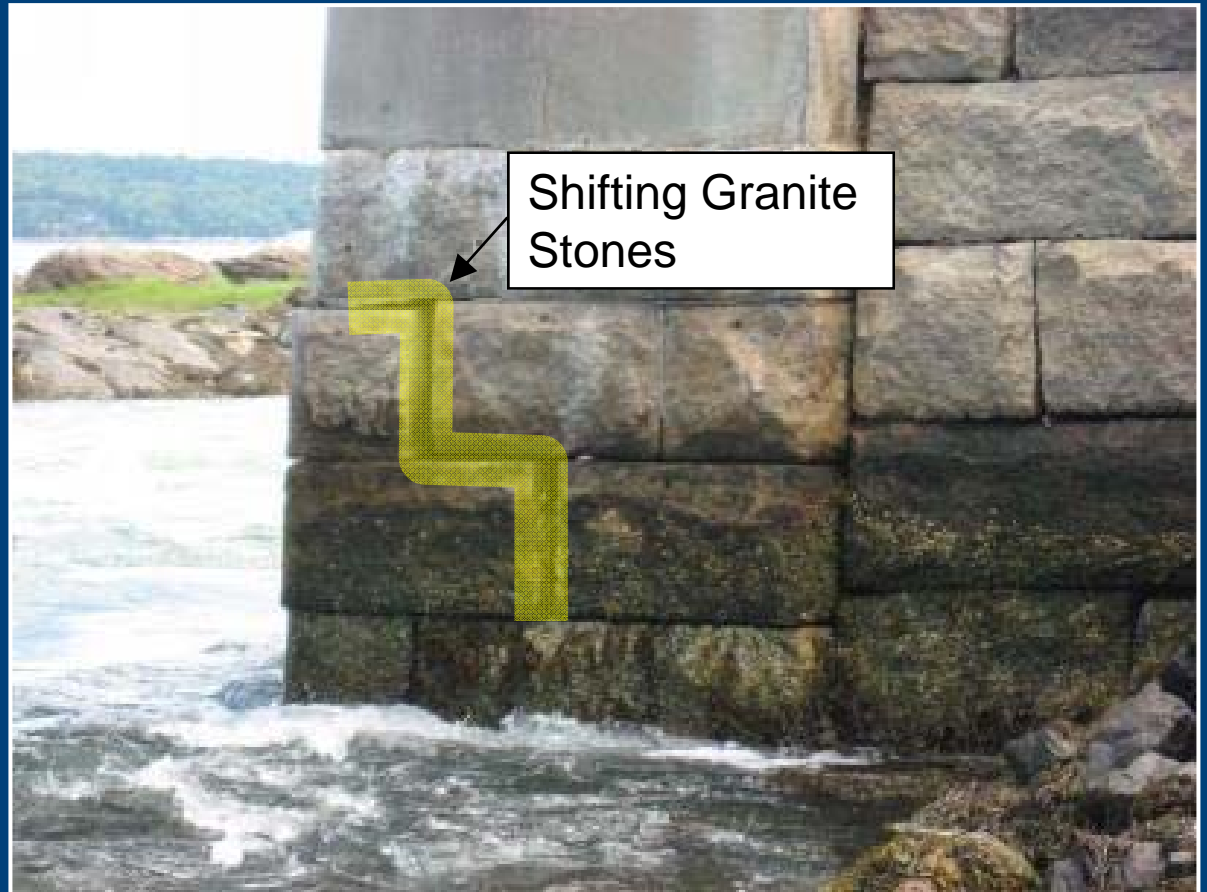
Shifting Granite
Stones

Settling & Shifting Masonry

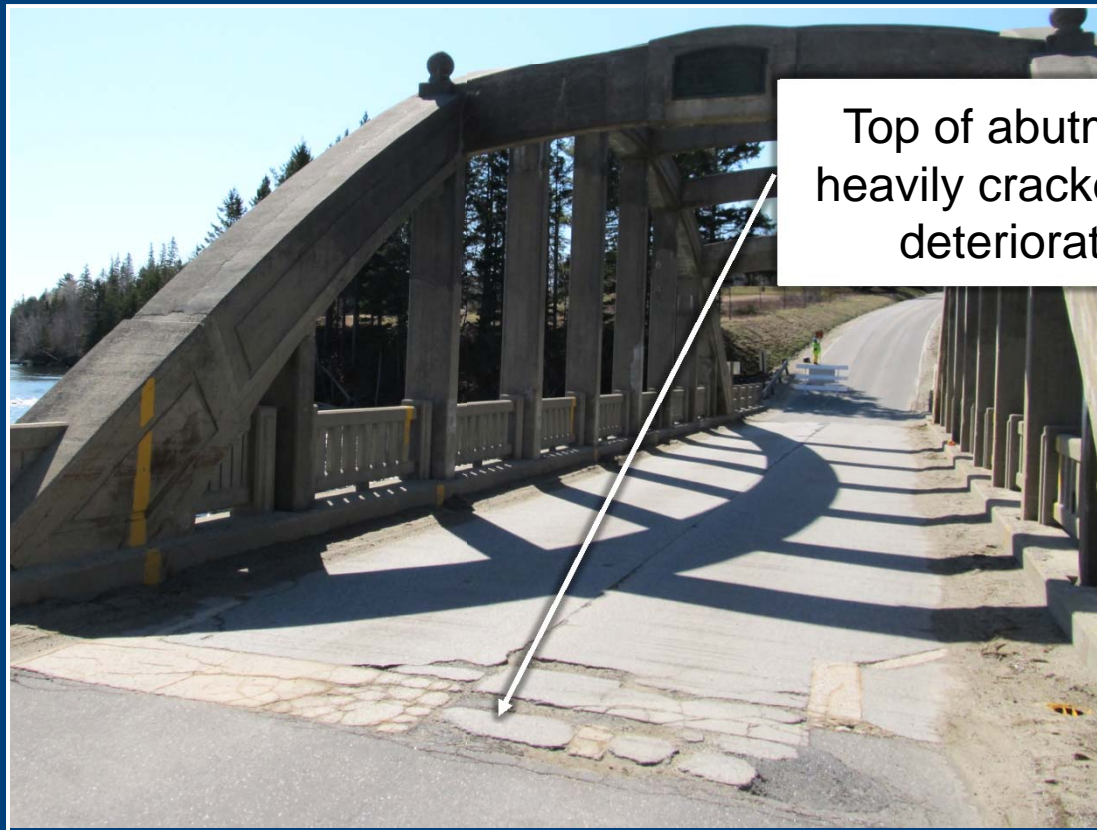
Top of abutments heavily cracked and deteriorated

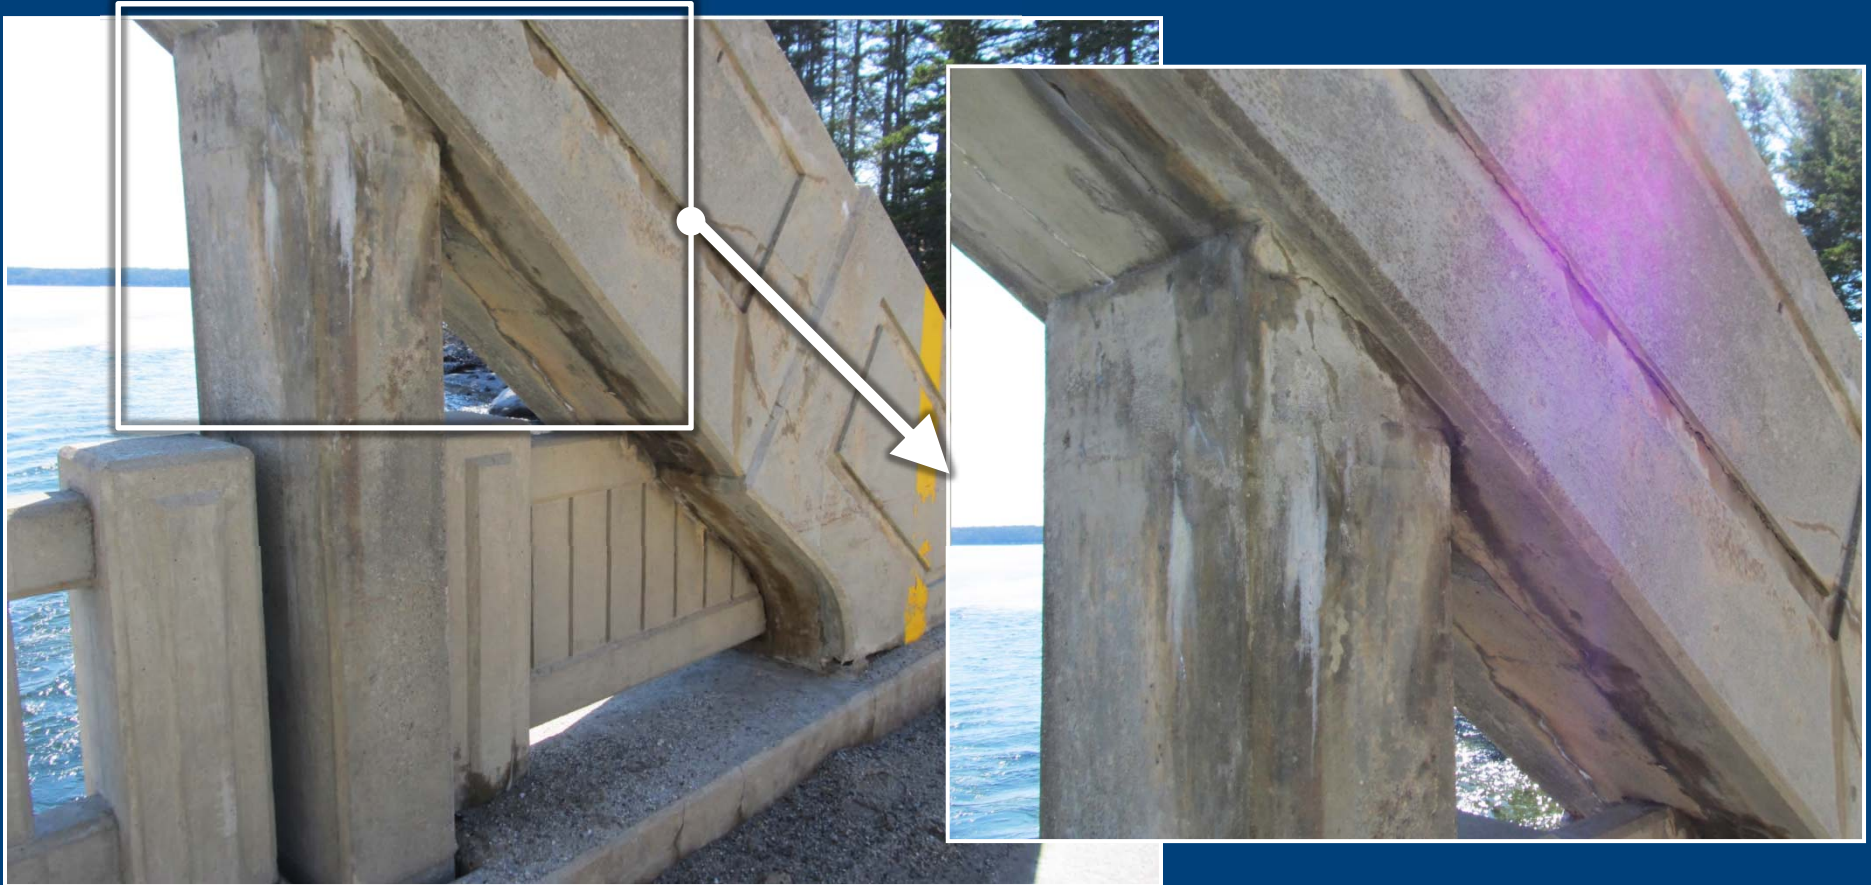
Rating = 5 – Fair Condition

Deteriorating Concrete at Northwest Knuckle
