Falls Bridge Advisory Committee Meeting #5 – Existing Conditions

BAC Meeting #5 – Existing Conditions

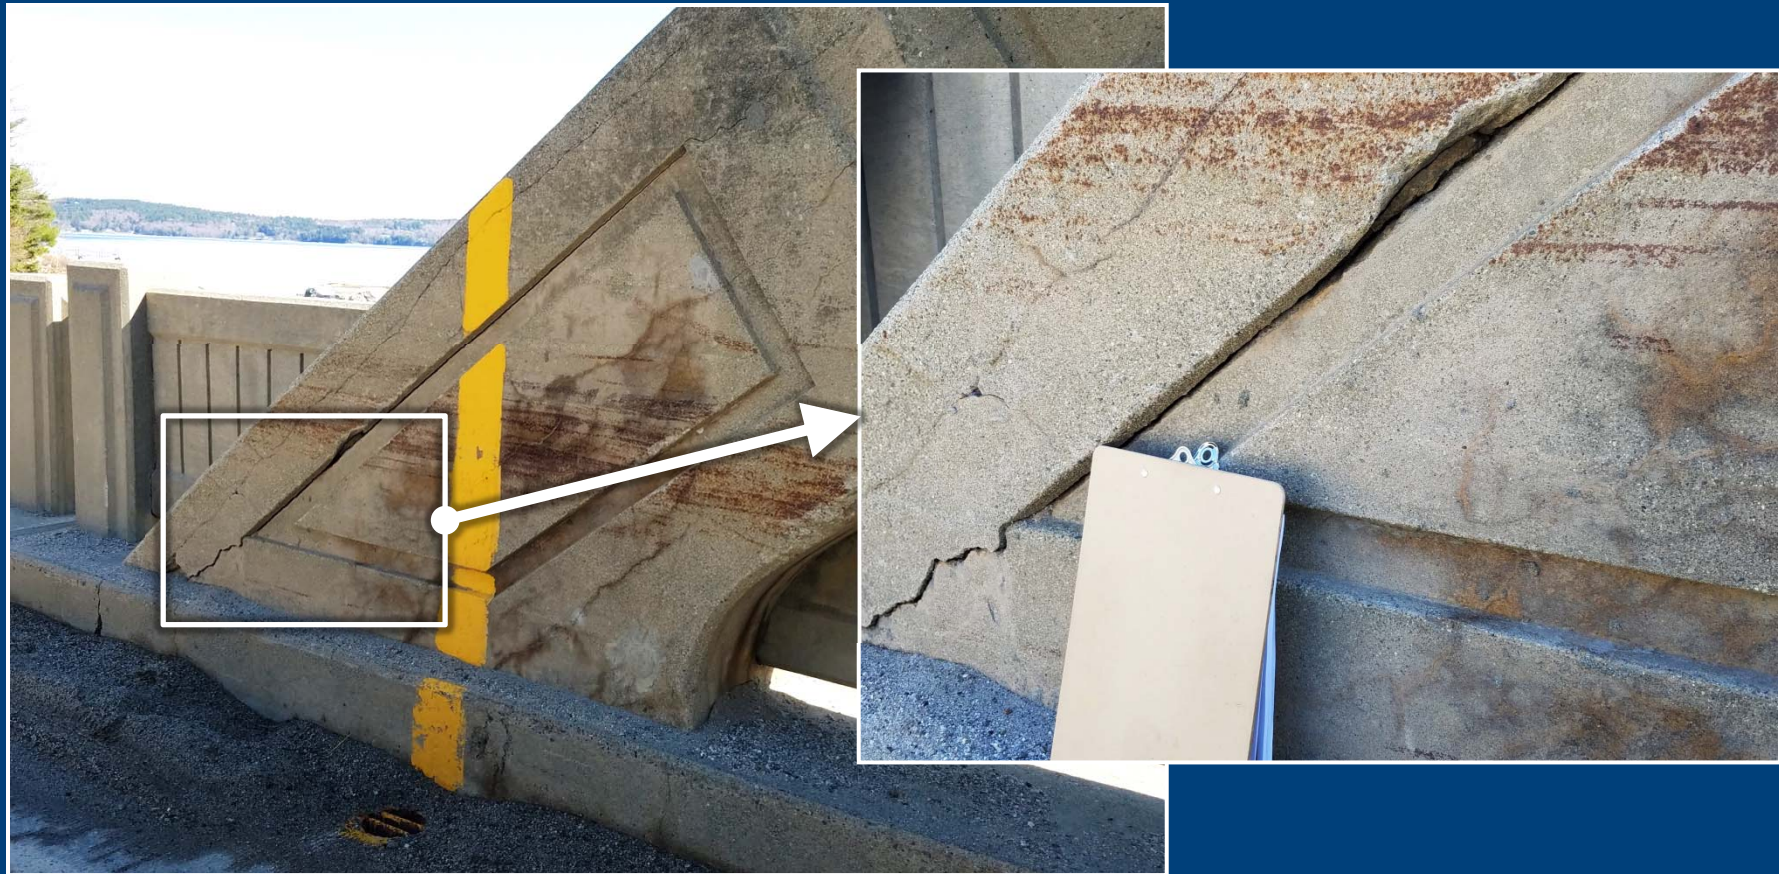
Rating = 5 – Fair Condition

Deteriorating Concrete at Northeast Knuckle

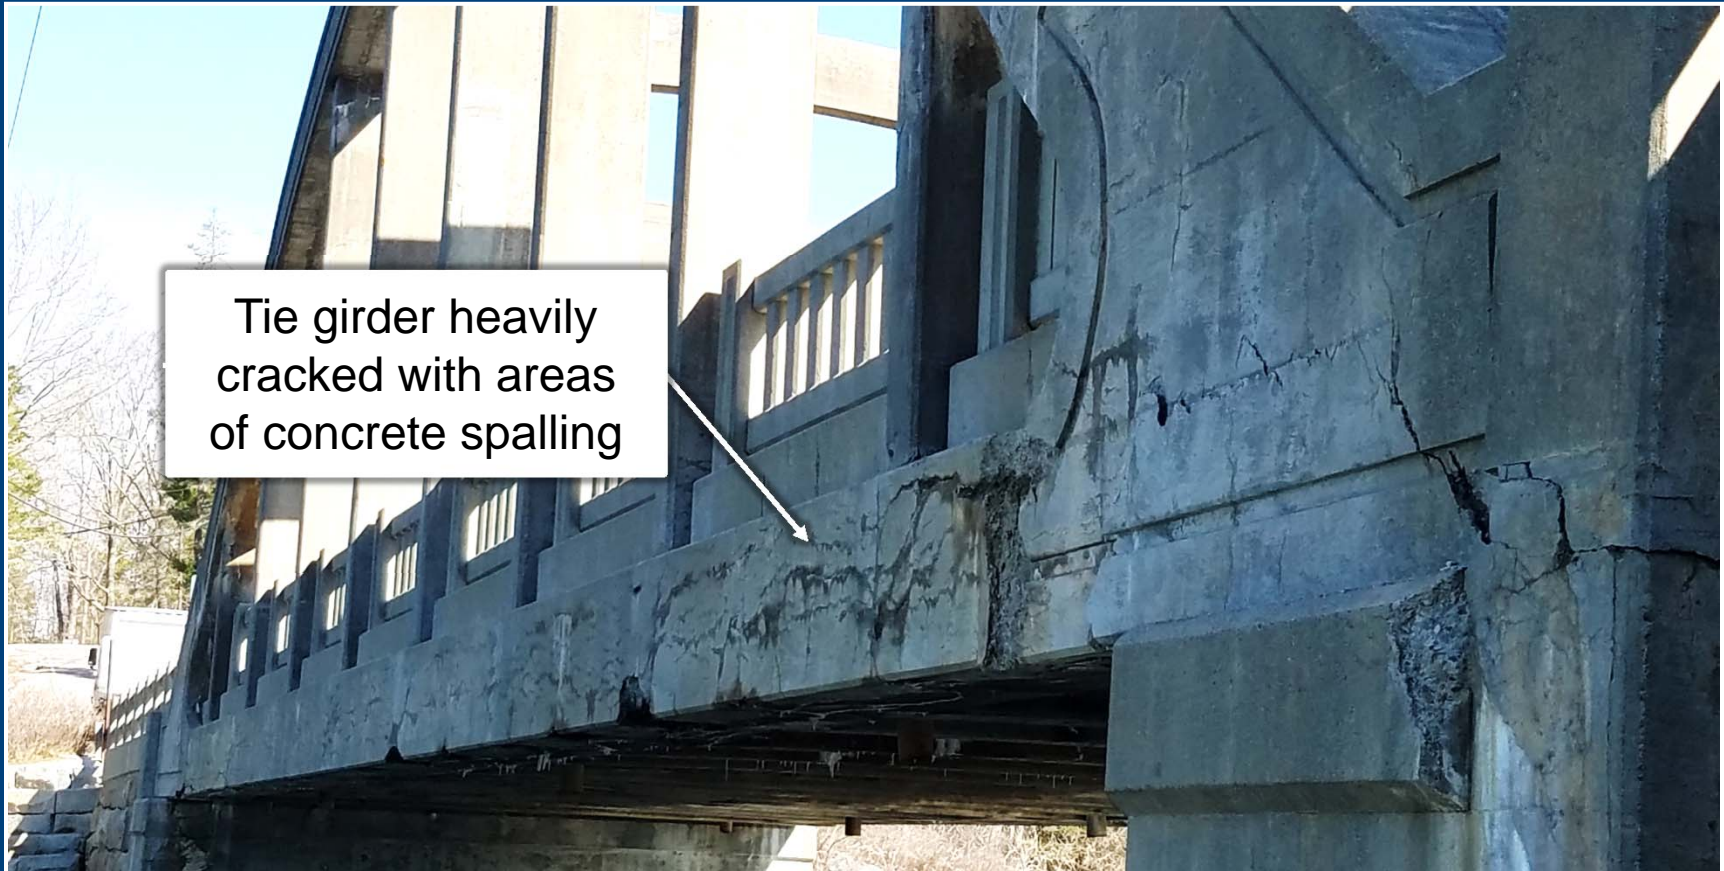
West Arch Tie Girder

Rating = 5 – Fair Condition

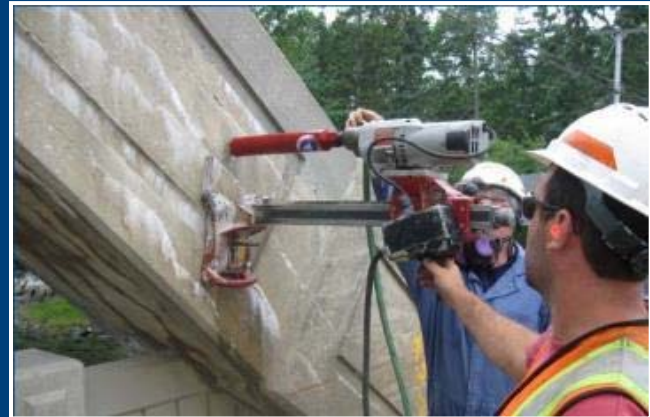
Concrete Coring

- Concrete Cores collected
 - Compressive strength testing
 - Chloride testing
 - Carbonation testing
 - Petrographic Testing
- Data will be used to support the development of a comprehensive rehabilitation strategy

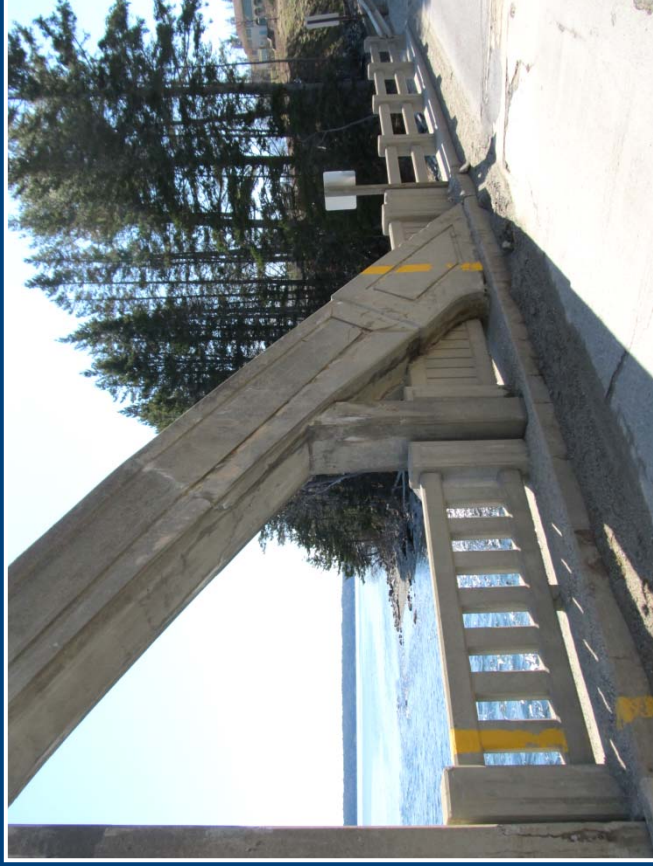
Existing Bridge and Approach Railing

- Example of substandard elements requiring evaluation
 - Roadway geometrics
 - Guardrail, bridge railing and approach railing
